# **Monitoring and Mitigation of Sustained Localized Pitting Corrosion**

**FINAL REPORT  
DOE FEW 49297**

YuPo J. Lin, Edward J. St.Martin, and James R. Frank  
Argonne National Laboratory  
Argonne, IL 60439

January 2003

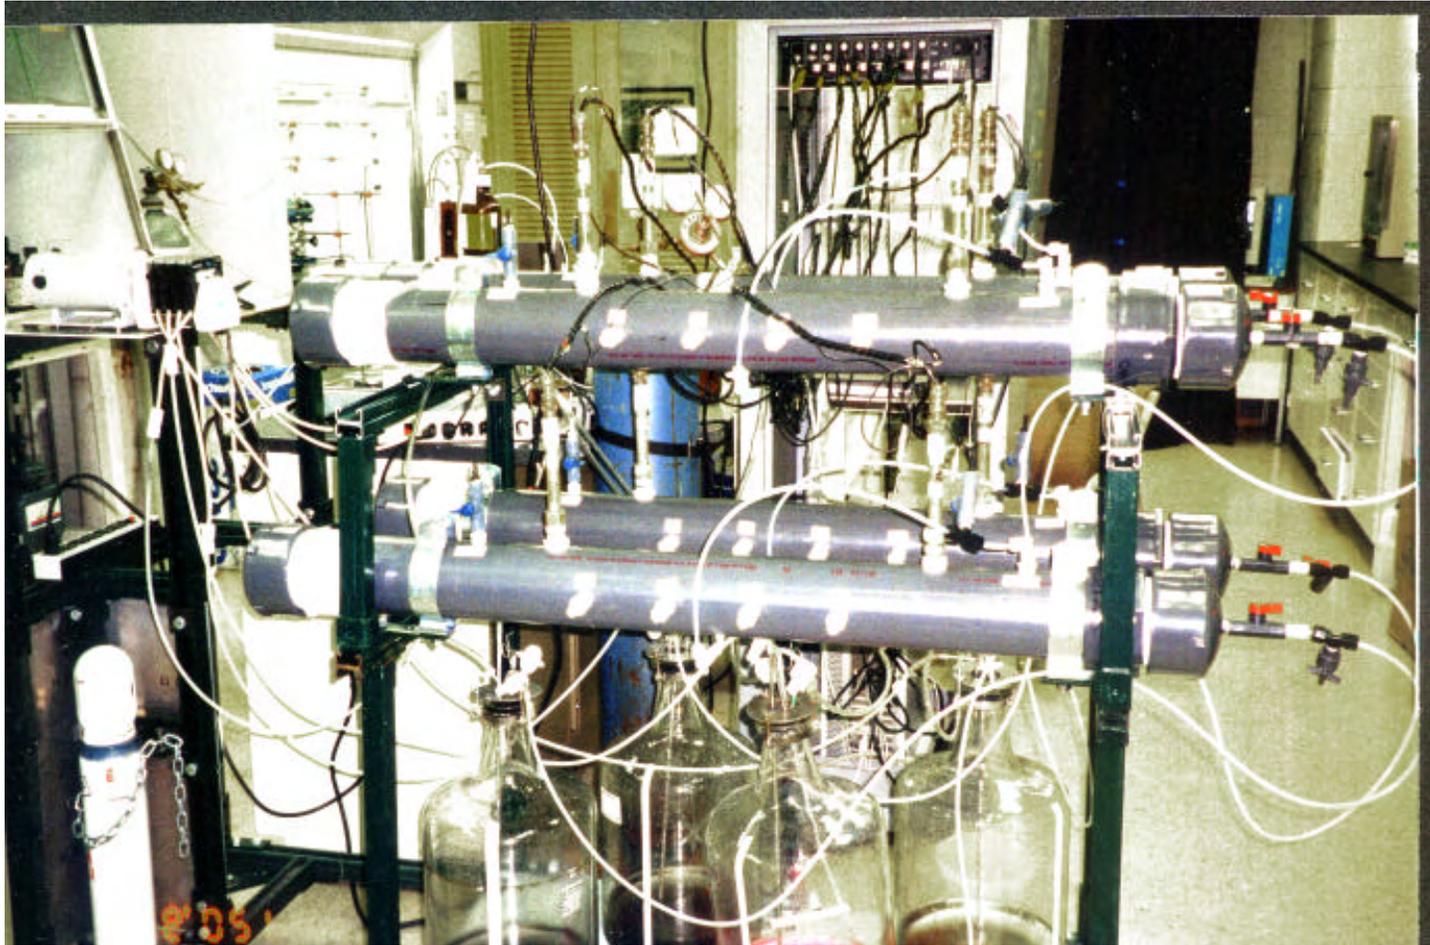
FIGURE 1: Flow loops testing facility for simulated process fluids and material corrosion process evaluation.

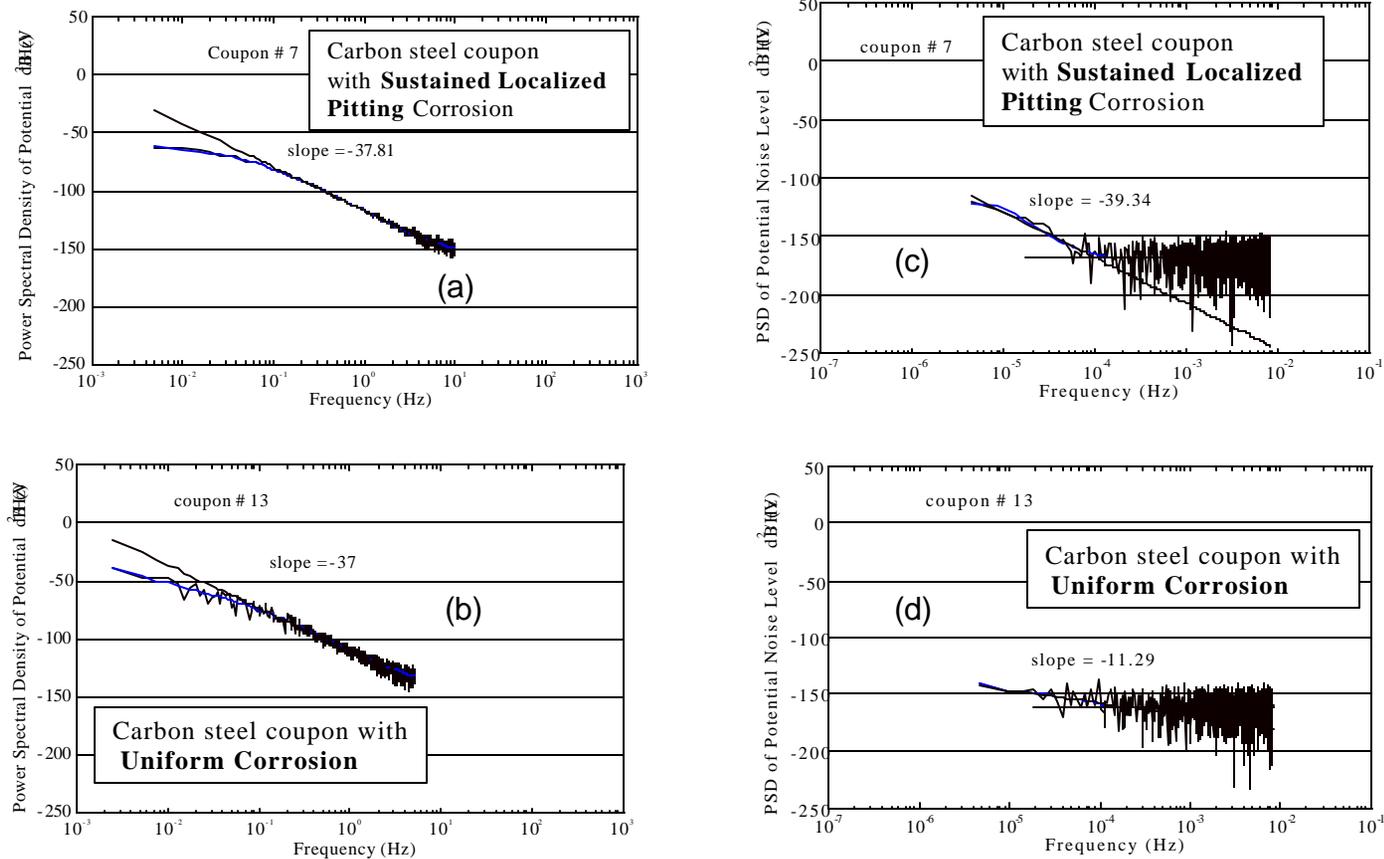
FIGURE 2: Power spectrum of electrochemical noise data acquired by zero-resistance measurement of conventional as well as Argonne's new data acquisition system.

- (a) Coupon sample with pitting corrosion, by conventional data acquisition system.
- (b) Coupon sample with uniform corrosion, by conventional data acquisition system.
- (c) Coupon sample with pitting corrosion, by Argonne's data acquisition system.
- (d) Coupon sample with uniform corrosion, by Argonne's data acquisition system.

Figures 2(a) and (b) show the PSD of conventional ENA of SLP and uniform corrosion on metal coupons. The potential PSD in both cases shows a very similar value of slope (i.e.,  $1/f^\alpha$ ,  $\alpha = 37$ ) with the linear portion of each line, both bending at a frequency of around 0.1 Hz. On the basis of Figure 1, it appears that the conventional PSD of potential (PSDP) cannot be used to distinguish between SLP and uniform corrosion. This result was expected because of the difficulties caused by the interference generated in the low-frequency range of the PSD analysis. However, using the new ENA data acquisition procedure, Figures 2 (c) and (d) show a clear difference in the PSDs of measured potential noise level (PSDPNL). The slope (i.e., the  $-\alpha$ ) of the PSDPNL of the coupon with uniform corrosion is  $-11$ , while that of the coupon with SLP is  $-39$ . The  $\alpha$  value thus shows a significant difference between uniform corrosion and SLP.

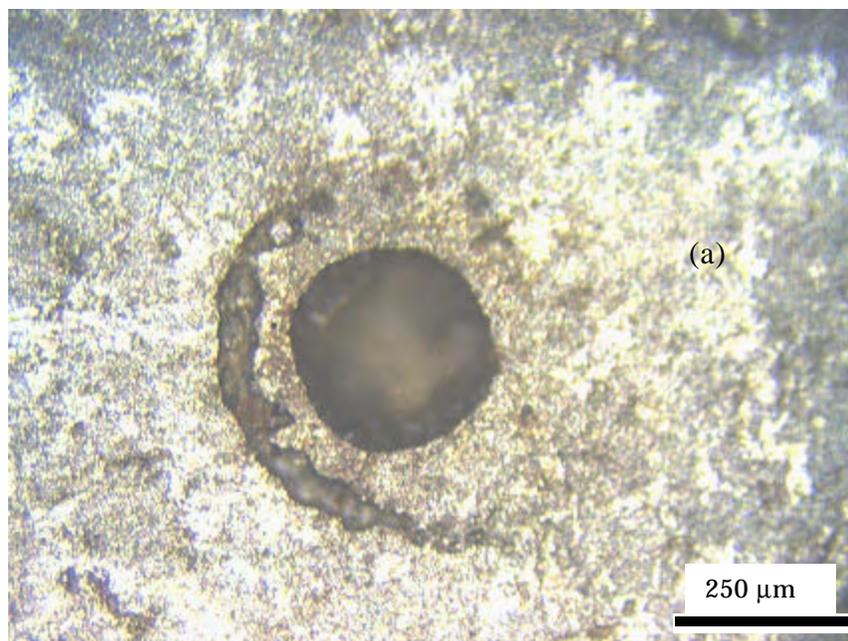
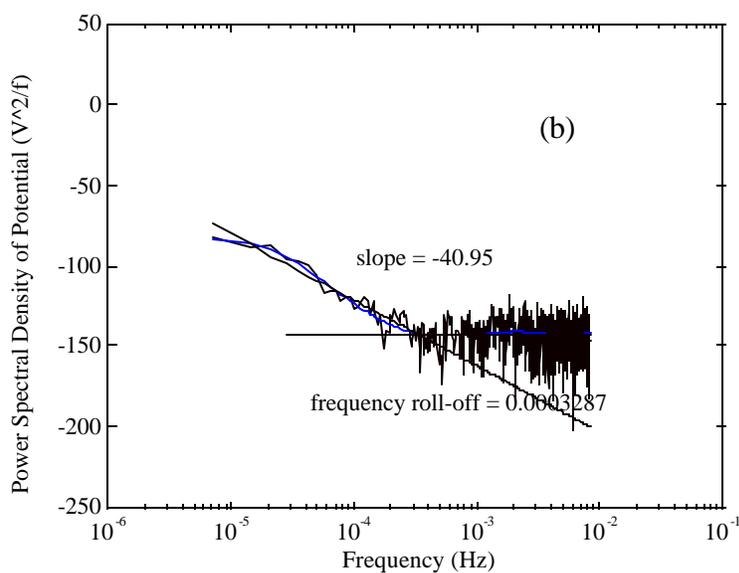
diameter : 275  $\mu\text{m}$ , depth : 88  $\mu\text{m}$

FIGURE 3: PSD of potential noise level and surface morphology of type I probe with S.S. 316 as counter electrode. The probe was immersed in water with traces of NaCl and purged with air; pH = 6.12.

The correlation of SLP corrosion with the PSDPNL is demonstrated for metal coupons in Figures 3 and 4. When SLP is in progress, the PSDPNL changes dramatically. Unlike uniform corrosion, which is represented by the stochastic process, once SLP occurs, the PSDPNL reveals a deterministic process. This process can be seen in Figure 3(a), which shows a carbon steel coupon with deep pits. Because the coupon was immersed in pure water with air purge only, a passivation film of iron hydroxide covered most of the coupon surface area. However, traces of chloride or other ions exist in the water and aid in the formation of pits. The PSDPNL (Figure 3[b]) shows a  $\alpha$  value of 40 in the low-frequency portion, which indicates a deterministic process. Depending on the total number and depth of the pits that are forming, the  $\alpha$  value for the PSDPNL could vary from 0 to 40, which reflects the domination of the SLP corrosion formation, compared with uniform corrosion. When the  $\alpha$  value is between 10 and 30, the metal surface is under an intermediate corrosion process attack. In this regime, the pits were either relatively shallow, or many shallow pits were merging to form a group of pits that extended over a large portion of the total surface area. An example of uniform corrosion caused by shallow and uniformly distributed pits is shown in Figure 4. In this case, the coupon was immersed in deionized water for 68 h. The final  $\alpha$  value of the PSDPNL is 15; the surface morphology shows that shallow pits have formed on the coupon surface. This apparently indicates a less-dominating deterministic process of small pit formation, compared with the stochastic process of uniform corrosion. A comparison between the coupon in Figure 3 and the coupon in Figure 4 supports the hypothesis of a competition between a deterministic and a stochastic process more clearly. The operating conditions for coupons in Figure 3 and Figure 4 were the same. However, the coupon shown in Figure 3 has much deeper pits than the coupon in Figure 4. The total number of pits on the coupon in Figure 4 is greater than that on the coupon in Figure 3 (the total pit number ratio  $\approx 50/5$ ). The aggressiveness of SLP corrosion (i.e., the domination of the deterministic process over the stochastic process) shown in Figure 3 makes its  $\alpha$  value near 40. The overall corrosion rate for the coupon in Figure 3 is one order of magnitude smaller than that for the coupon in Figure 4 (i.e.,  $1.08 \times 10^{-2}$  mg/h vs.  $1.78 \times 10^{-1}$  mg/h from the weight loss measurement). These results are also evidence for the domination of SLP over uniform corrosion.

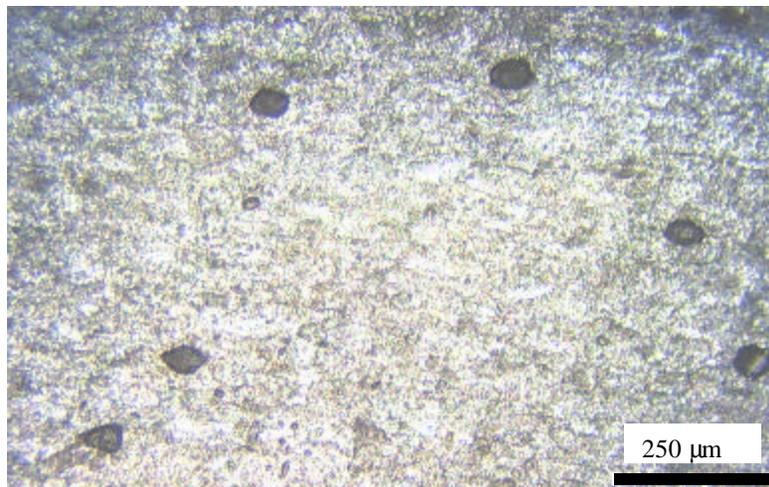
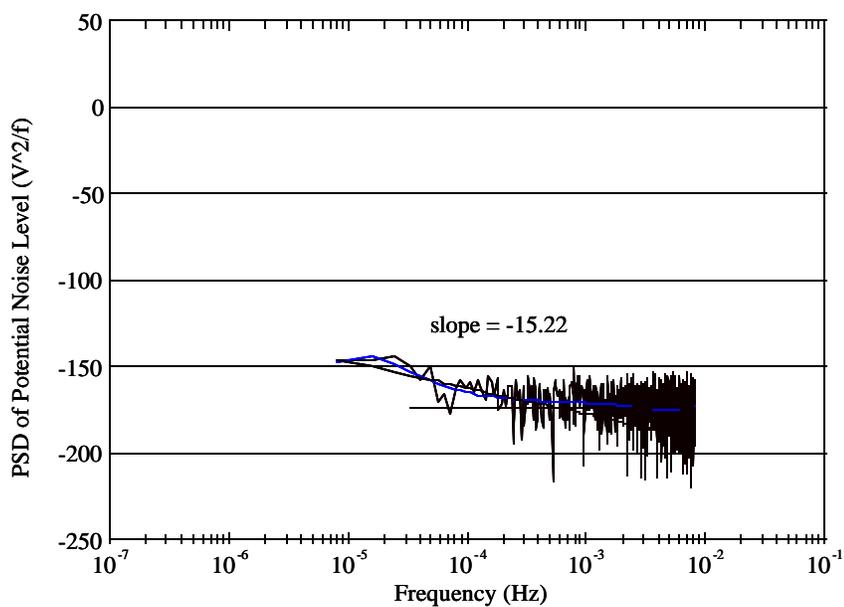
small pits uniformly distributed on the front surface  
diameter: 50 μm, depth: 11 μm

FIGURE 4: PSD of potential noise level and surface morphology of type I probe with S.S. 316 as counter electrode. The probe was immersed in water and purged with air; pH = 6.97.

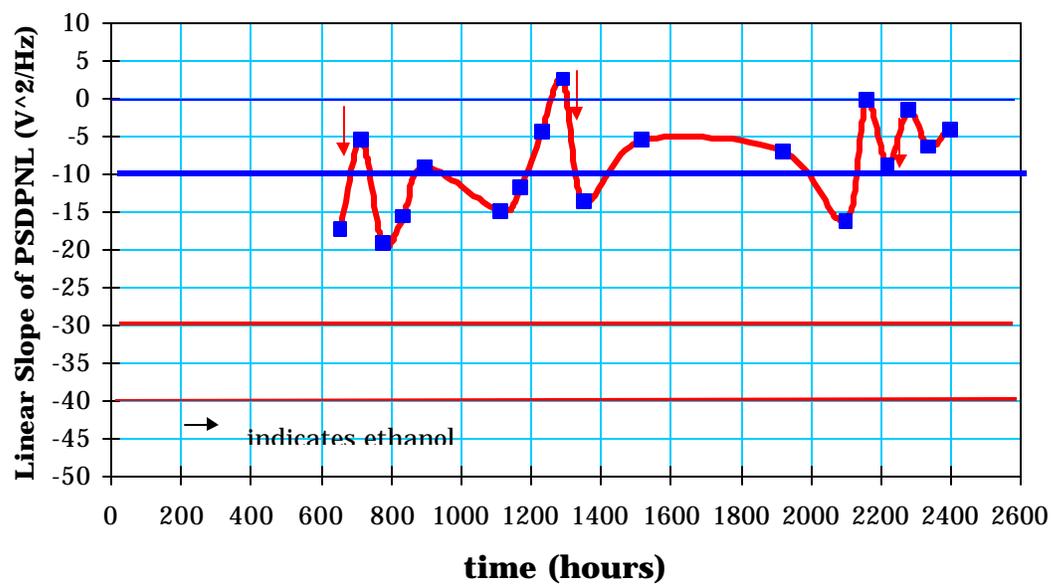
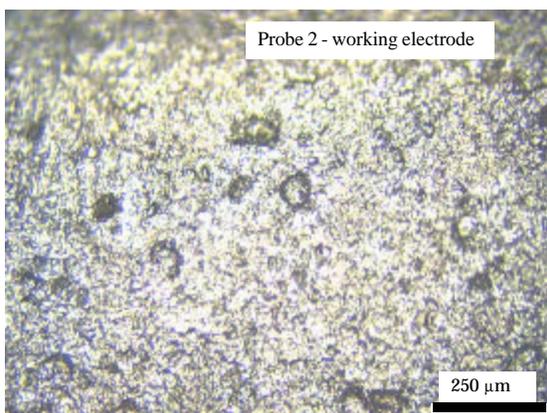
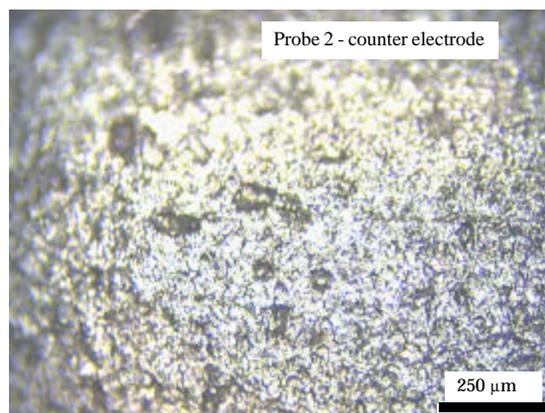
diameter  $\approx$  30-50  $\mu\text{m}$ ; depth  $\approx$  10-12  $\mu\text{m}$ ; surface roughness  $\approx$  3  $\mu\text{m}$

diameter  $\approx$  40  $\mu\text{m}$ ; depth  $\approx$  10  $\mu\text{m}$ ; surface roughness  $\approx$  3  $\mu\text{m}$

FIGURE 5: Change profile of PSDPNL and morphology of probe 2 from flow loop A.

To evaluate the performance of the new ENA technique in detecting SLP, several chemicals were added to accelerate MIC pitting. Ethanol was injected into each loop to introduce acetic acid production and trigger pitting corrosion during the test period. Figure 5 shows the slope profile (5a) of PSDPNL and the morphology on the tip of the probe (5b). As discussed above, the slope indicates that uniform corrosion was dominating the corrosion process. This finding was confirmed by the morphology on the tip shown in Figure 5(b).

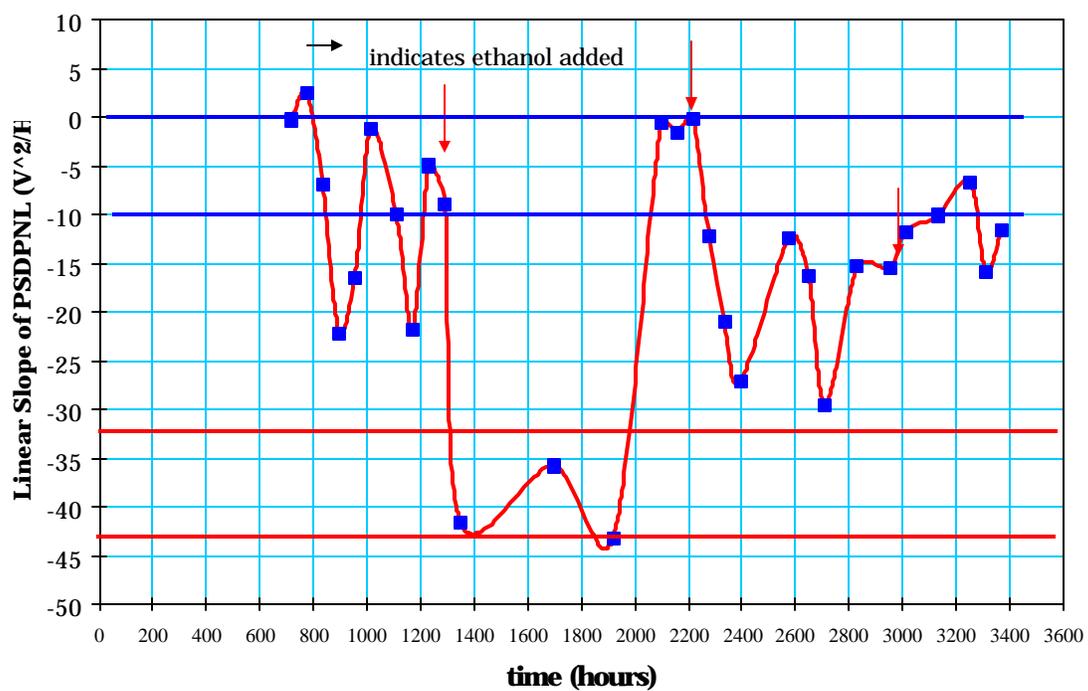
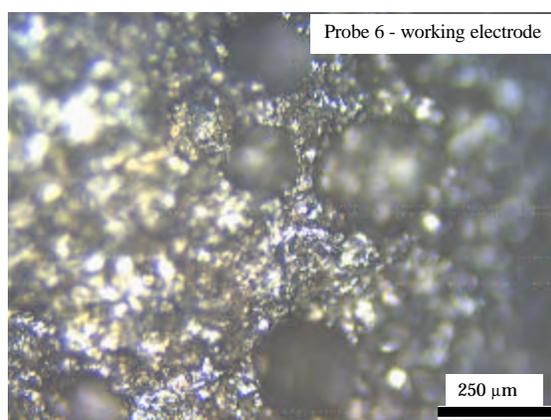
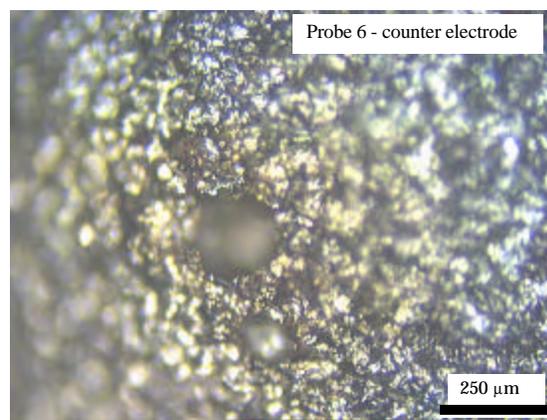
diameter  $\approx 125 \mu\text{m}$ ; depth  $\approx 80 \mu\text{m}$ ; surface roughness  $\approx 3 \mu\text{m}$

diameter  $\approx 120 \mu\text{m}$ ; depth  $\approx 37 \mu\text{m}$ ; surface roughness  $\approx 3 \mu\text{m}$

FIGURE 6: Change profile of PSDPNL and morphology of probe 6 from flow loop.

Figure 6(a) shows the change in slopes in PSDPNL during the test period from a separate probe in a different loop. From the change in profile of the PSDPNL slopes, it is clear that uniform corrosion and pitting corrosion can alternate and dominate the corrosion process. The injection of ethanol was also able to trigger SLP, which is indicated by a decrease in the slope. Analysis of the change in profile of slope in the tested probes revealed that six out of the eight probes developed SLP. These results were confirmed by weight loss and morphology analysis of the probes after the test period. Figure 6(b) shows the morphology of the localized pitting corrosion attack on an electrode surface. Similar statistical correlation between maximum pitting rate or the total corrosion rate and several other parameters derived from the signal processing of the prescreened ENA data were attempted. None of them appeared to have a significant linear correlation constant.

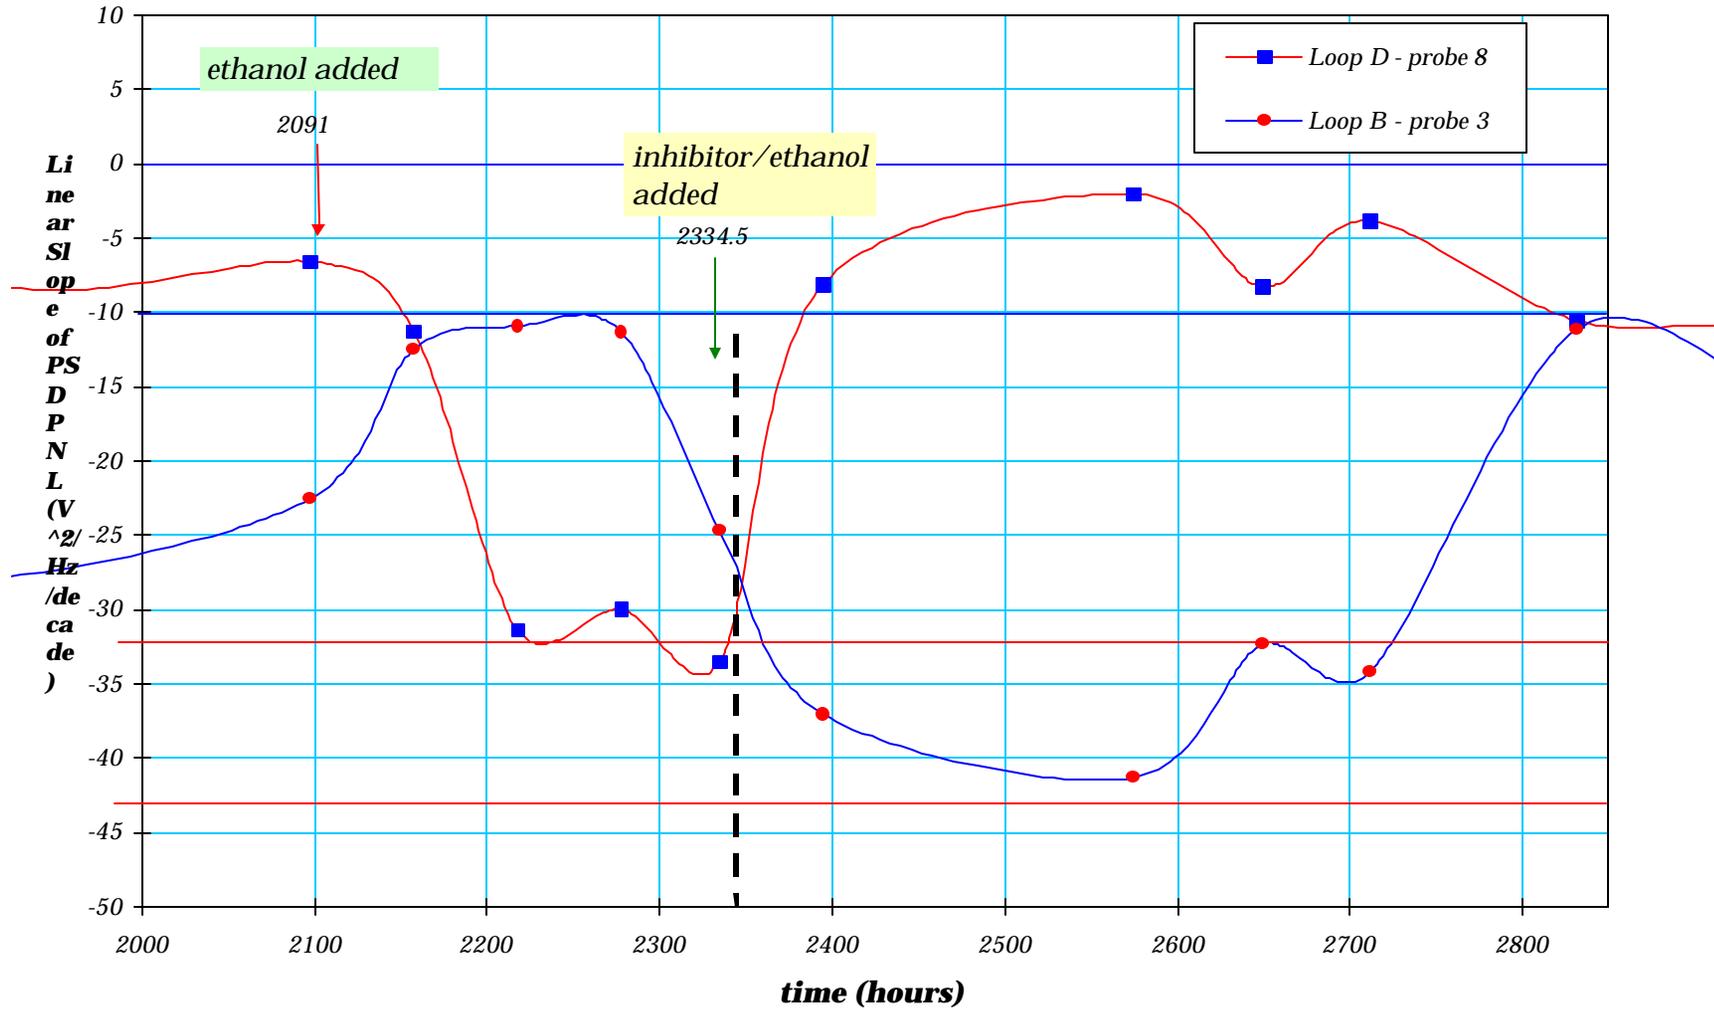
FIGURE 7: Change profile of PSDPNL's linear slope in different corrosion environments

Another experiment was performed in the flow loops to monitor the in-situ effectiveness of corrosion inhibitors in the test system. During the test period, corrosion inhibitor was added to loop D, while ethanol was added to both loops D and B. Figure 7 shows the change in the profile of the slope of PSDPNL in loops B and D. As expected, the PSDPNL slope of the probe in loop D changed immediately upon addition of the treatment chemical from an SLP signal to a uniform corrosion signal (i.e., larger than -10). On the other hand, the probe in loop B continued to show SLP signal. Therefore, it appears that the new ENA method can be used as an in-situ process monitor for corrosion control.

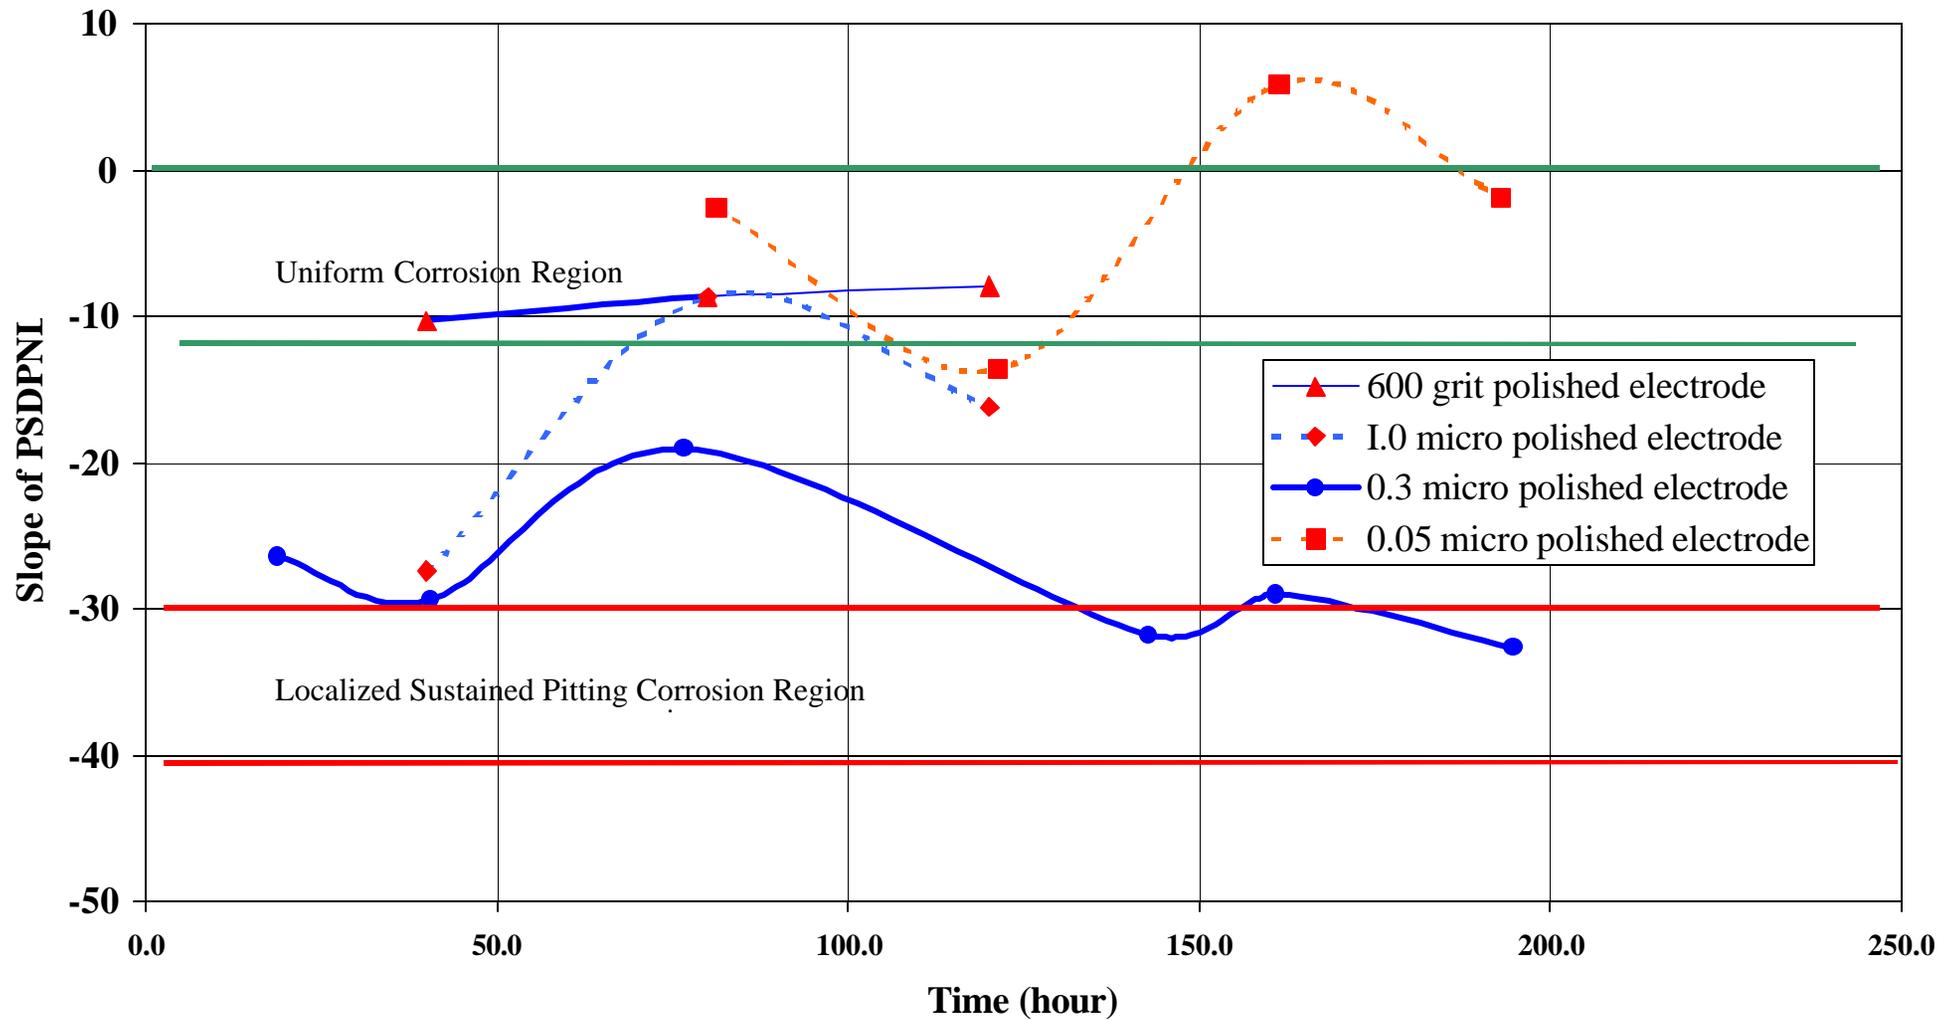
Figure 8 Slope profile of new ECN probes with SMEs.

To reproduce the results found for the new electrode design of ECN probe, two sets of experiments, runs ECN34 and ECN35 were carried out to demonstrate the increase of sensitivity to sustained localized pitting (SLP) corrosion on electrochemical noise (ECN) probes by using surface modified electrodes (SME) in a chemical corrosion environment (1.0 % NaCl solution). A total of four flow loops were used in runs ECN34 and ECN35. Each loop included one original ECN probe and one newly designed ECN probe. The new ECN probe consists of one SME and one non-surface-modified electrode (NSME). The original ECN probe includes two NSMEs. All of the four SMEs developed severe localized pitting corrosion (see tables 2 and 3). The maximum pitting corrosion rate (measured by using an optical microscope) on these SMEs was at least 2.5 times higher than the general or uniform corrosion rate (measured by weight loss). One of the SME showed 30 times higher localized pitting corrosion than the general corrosion rate (13.9 mpy vs. 0.42 mpy). None of the NSMEs developed significant localized pitting corrosion. Only uniform pitting corrosion, where small pits are uniformly seen all over the electrodes surface, was observed. The uniform pitting corrosion rates in these NSMEs were much smaller than their general corrosion rates. It was also demonstrated that the general corrosion rates of the NSMEs in the new ECN probes were linearly proportional to the total noise current. The linear correlation constant was as high as 95.6%. No such correlation was found using the original ECN probes. Thus, these probes can be used to measure the general corrosion rate directly from the total noise current measurements.

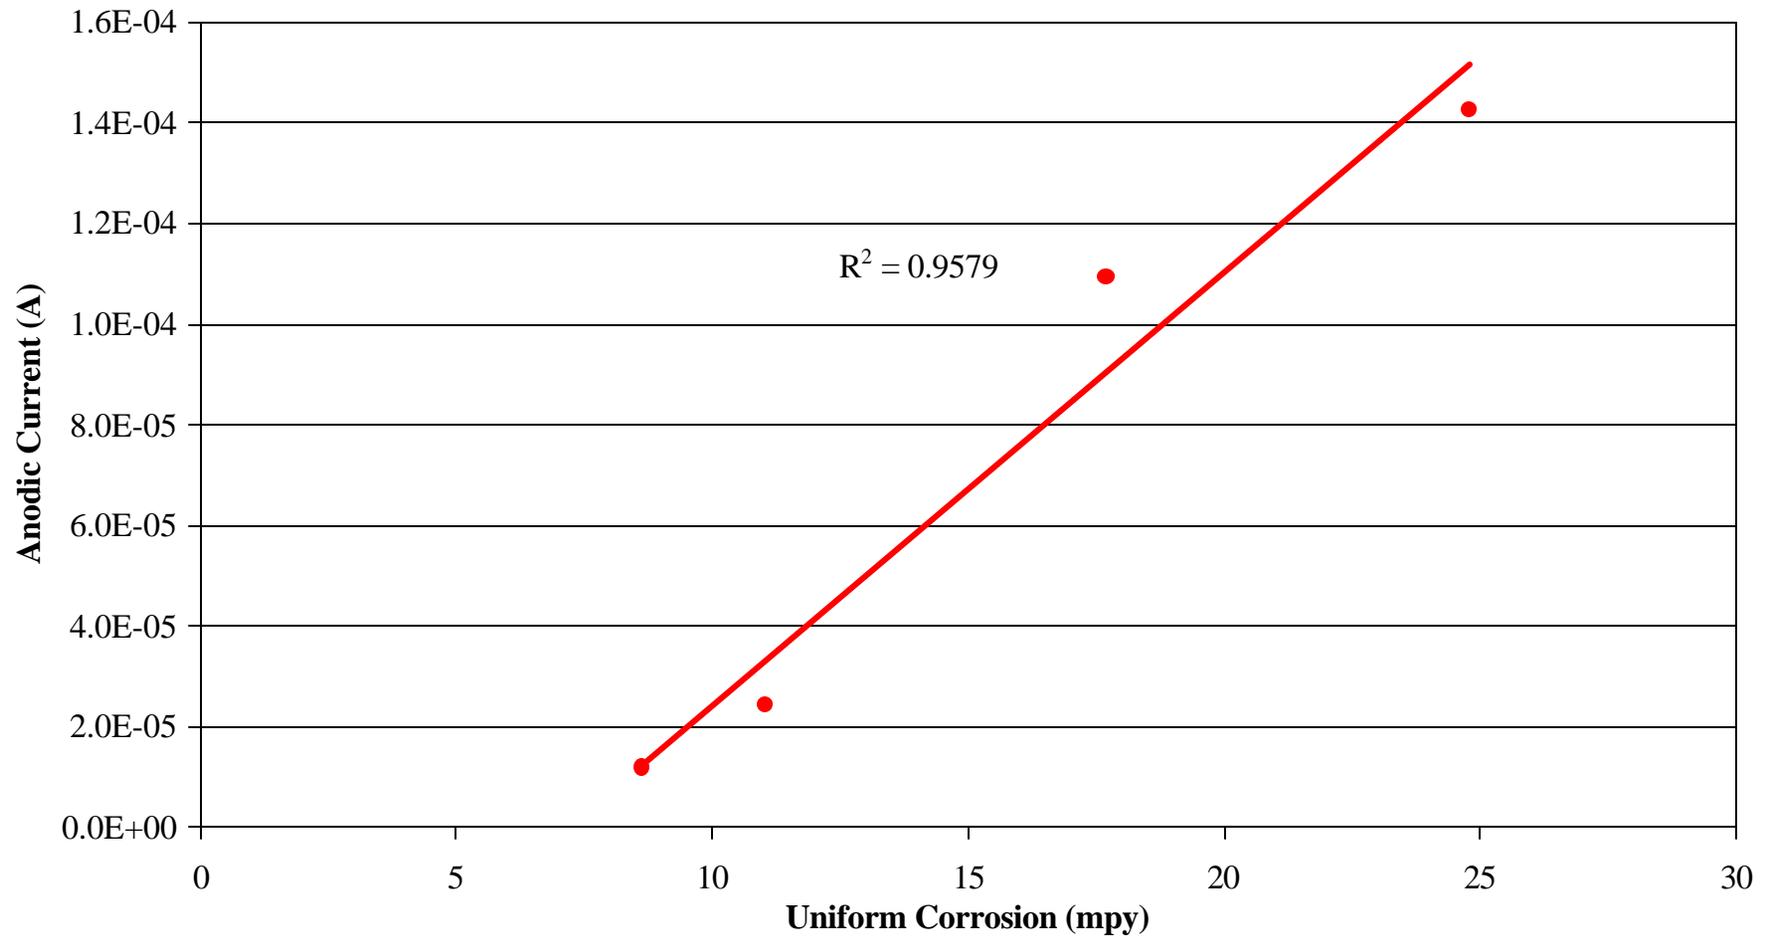
Figure 9 Correlation of average anodic current and the uniform corrosion rate in chemical corrosion environments

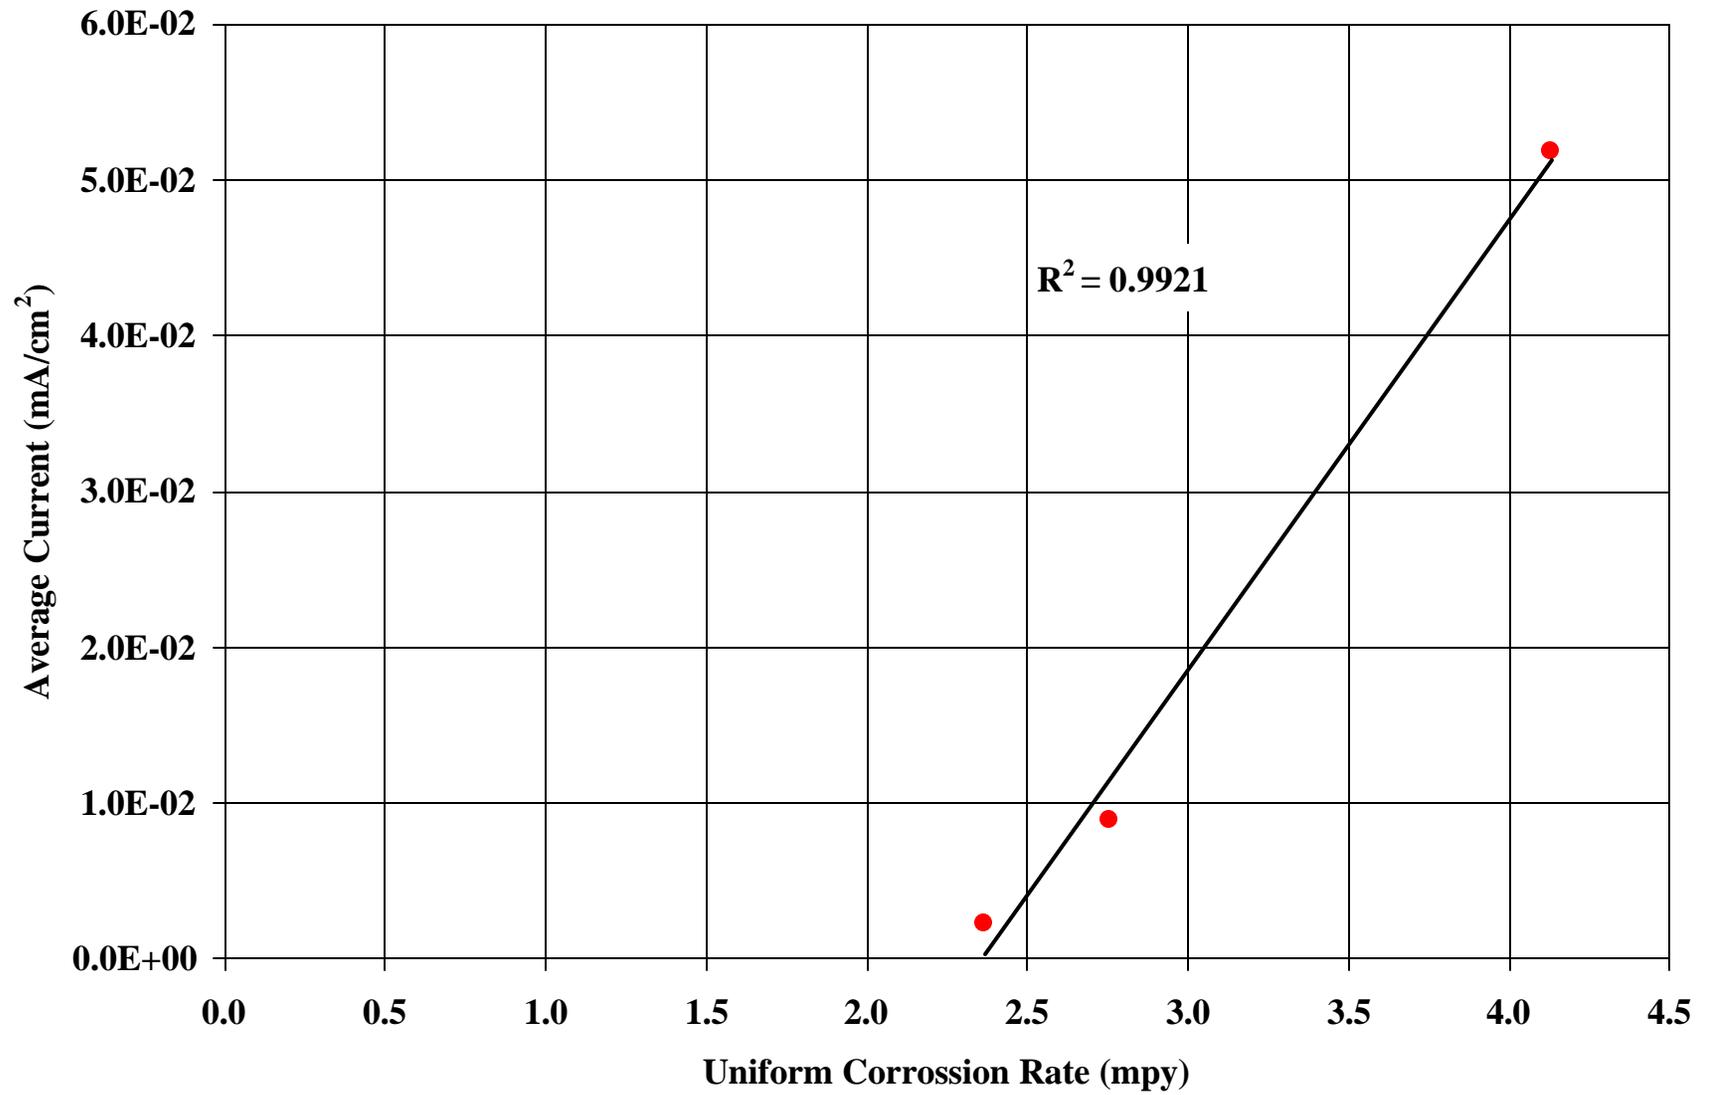
Figure 10 Correlation of average anodic current and the uniform corrosion rate in MIC environments

Experiment ECN 36 was carried out to demonstrate the new ECN electrode design in a microbially influenced corrosion (MIC) environment. The ECN probes were placed in a simulated produced water solution in the flow loop test system. The solution was inoculated with sulfate reducing bacteria and acid produce bacteria that are responsible for initiating microbially influenced corrosion. Two flow loops were used. Each loop included one original ECN probe and one newly designed ECN probe. The new ECN probe consists of one SME and one non-surface-modified electrode (NSME). The original ECN probe includes two NSMEs. The experiment lasted more than 1,200 hours. The two SMEs developed severe localized pitting corrosion (see table 4). The maximum pitting corrosion rate (measured by using an optical microscope) on these SMEs was 4 to 7 times higher than the general or uniform corrosion rate (measured by weight loss). None of the NSMEs developed significant localized pitting corrosion. Only uniform pitting corrosion, where small pits are uniformly seen all over the electrodes surface, was observed. The uniform pitting corrosion rates in these NSMEs were much smaller than their general corrosion rates. The correlation between current noise and the uniform corrosion rate was as high as 99% (Figure 10).

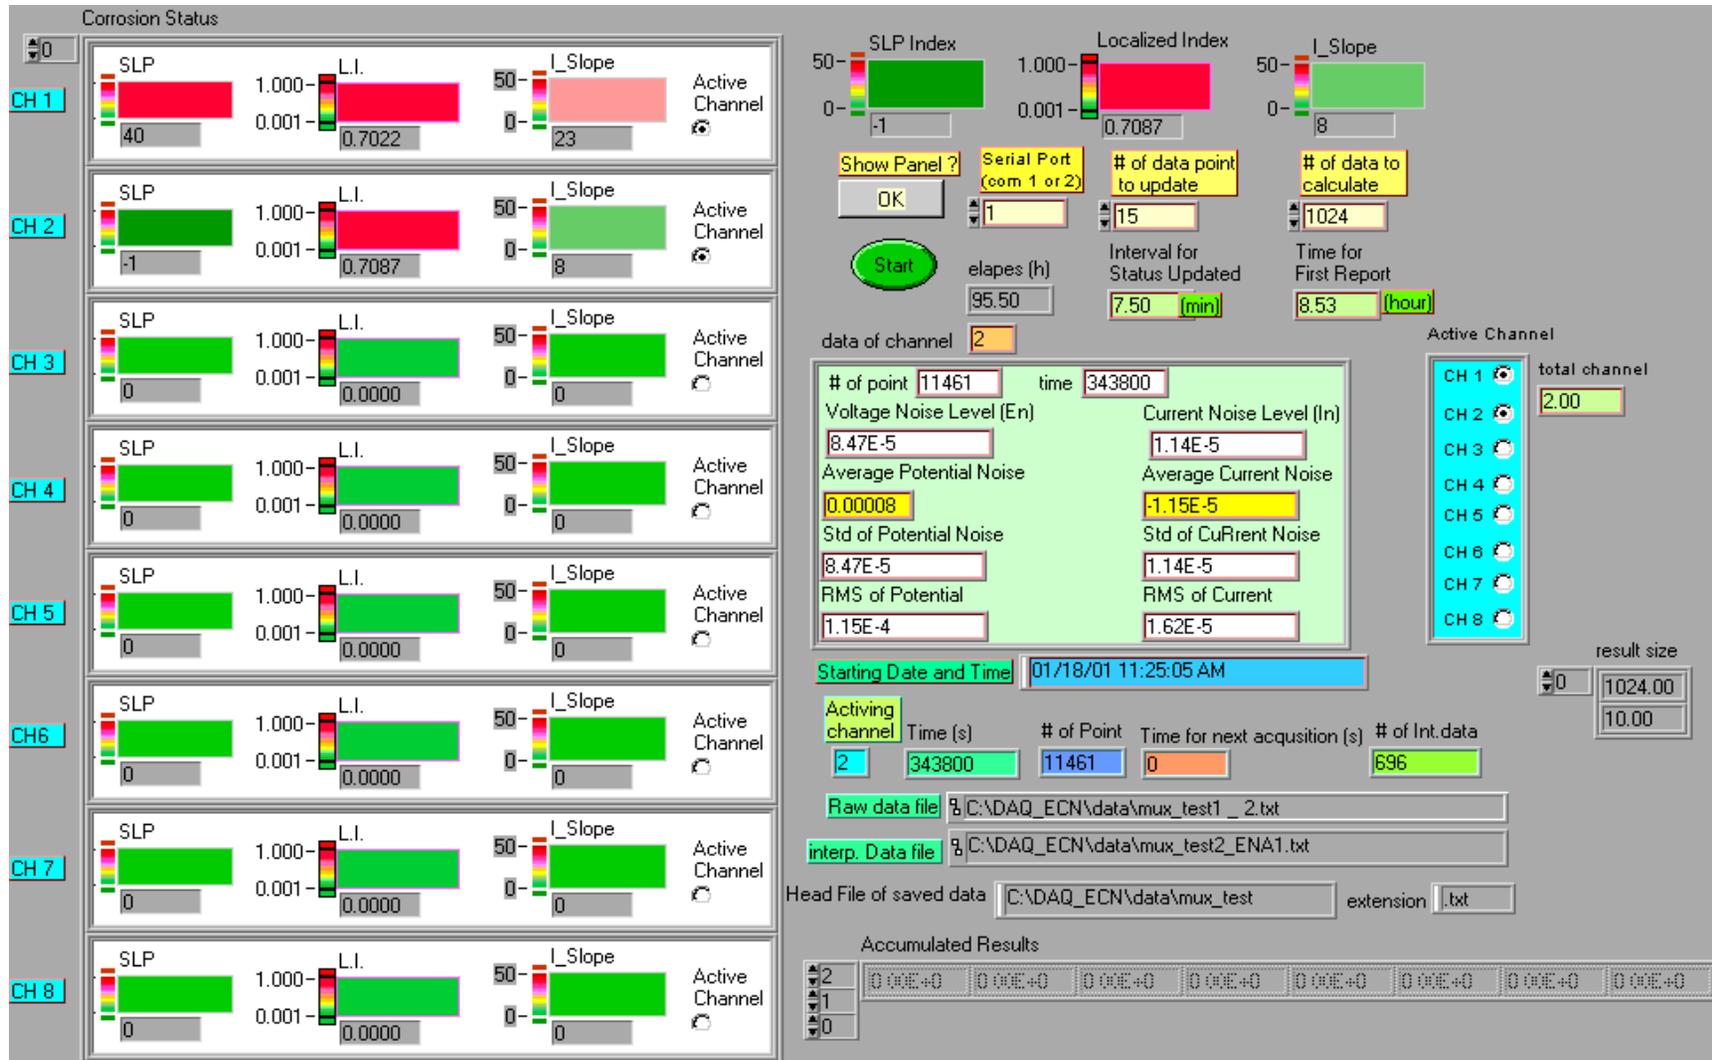
Figure 11 Display Screen of the Automatic ECN analysis System

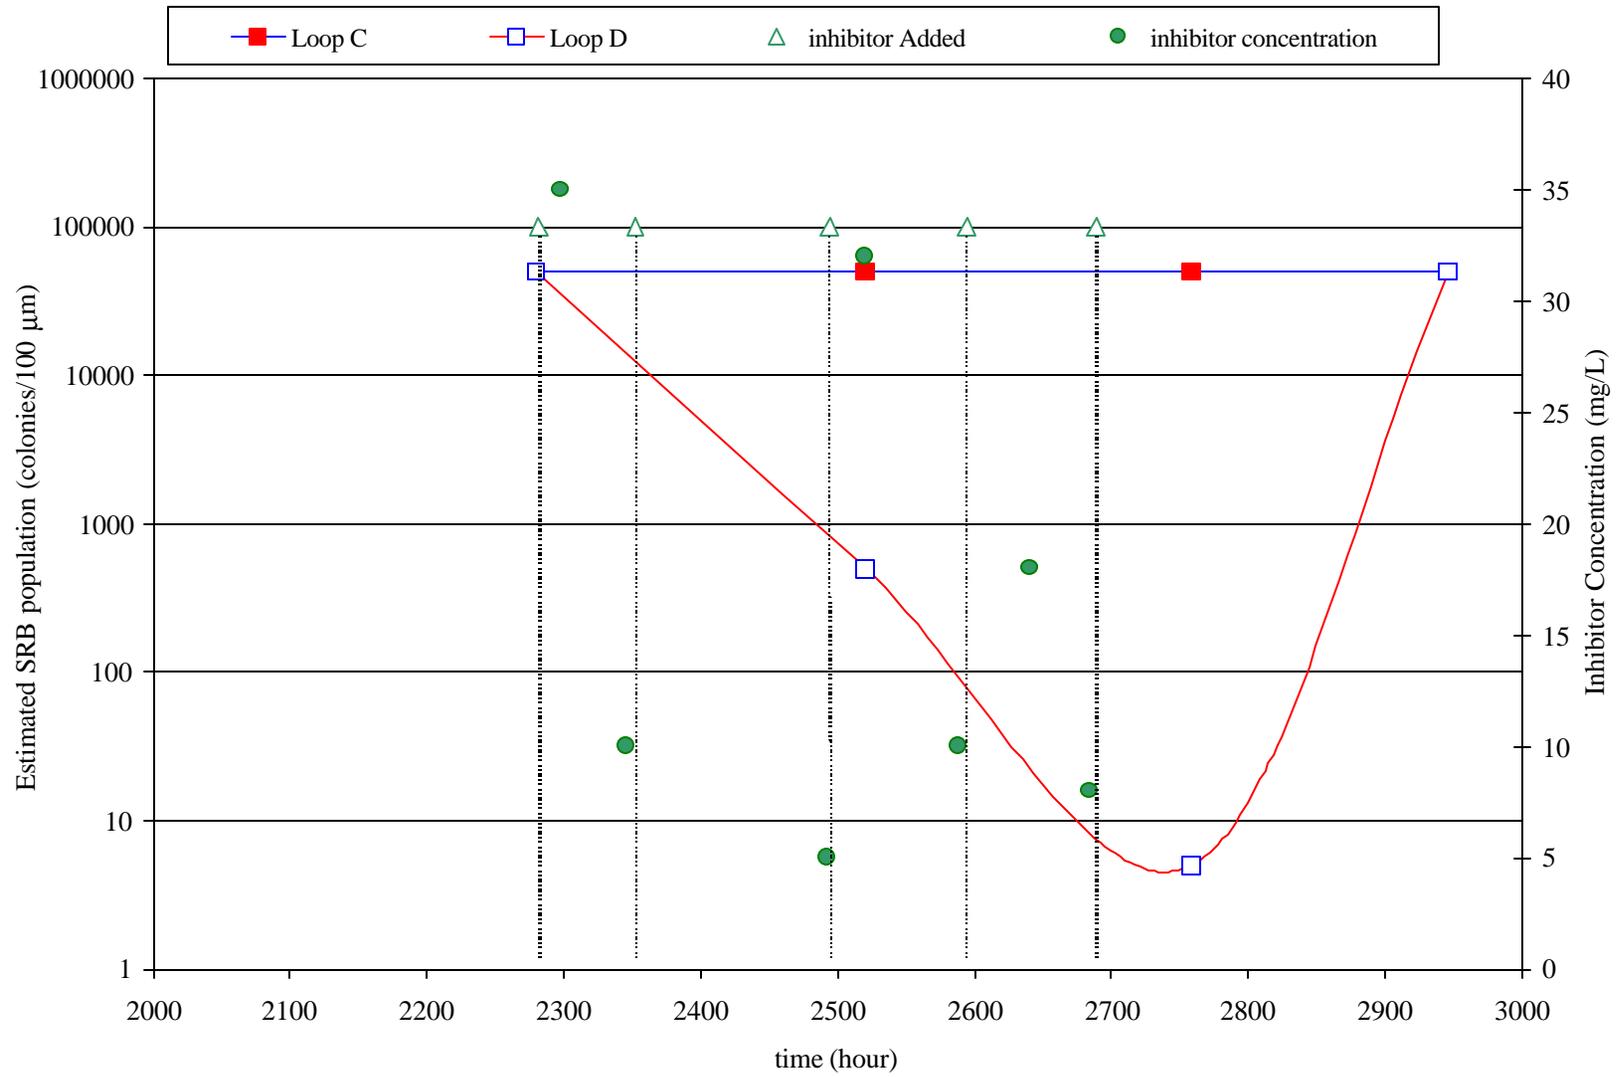
Figure 12 Comparison of SRB and APB population in Loop C and D

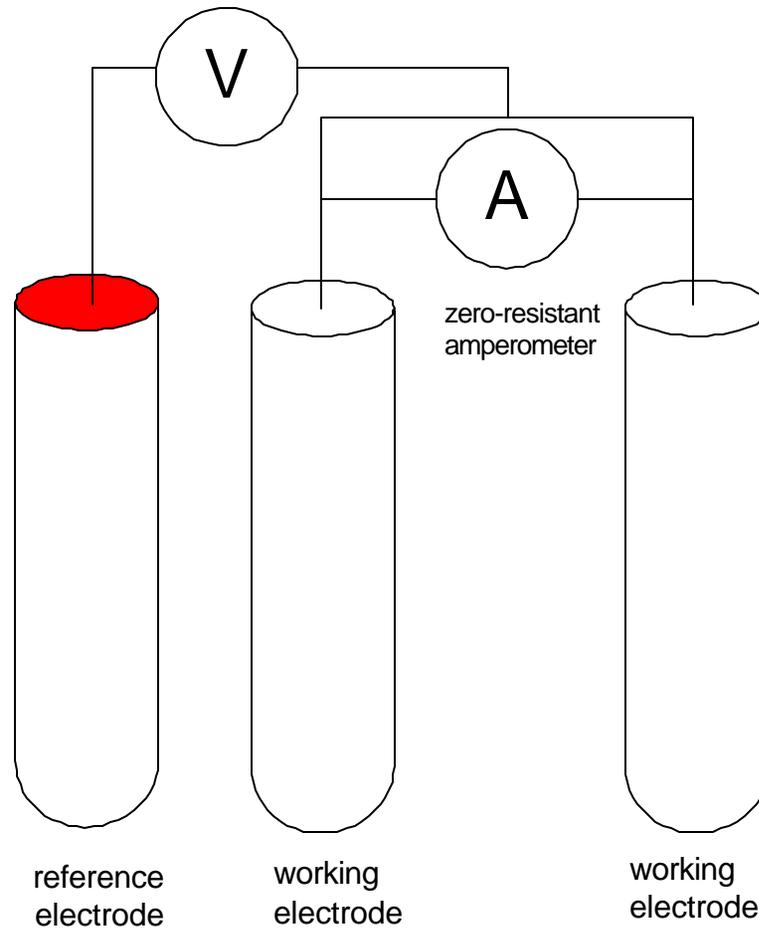
Figure 26 Three electrodes system with zero-resistant amperometer (a computer plug-in potentiostat). Carbon steel was used in the two working electrodes and the reference electrode was a Hastalloy

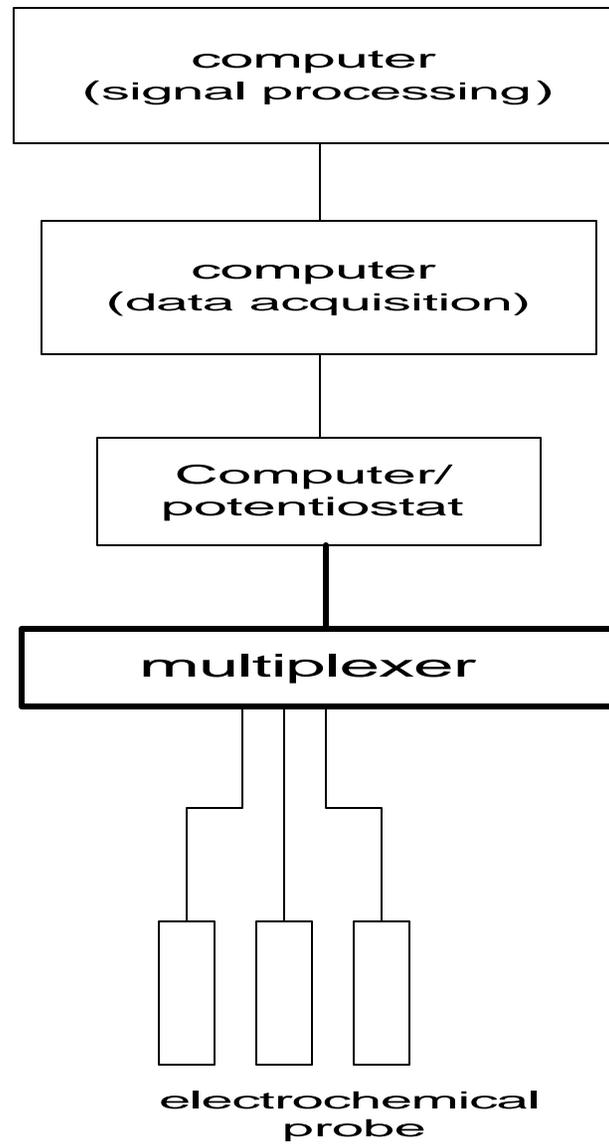
Figure 27 Schematic of the field unit for ECN measurement
