# **Monitoring and Mitigation of Sustained Localized Pitting Corrosion**

**FINAL REPORT  
DOE FEW 49297**

YuPo J. Lin, Edward J. St.Martin, and James R. Frank  
Argonne National Laboratory  
Argonne, IL 60439

January 2003

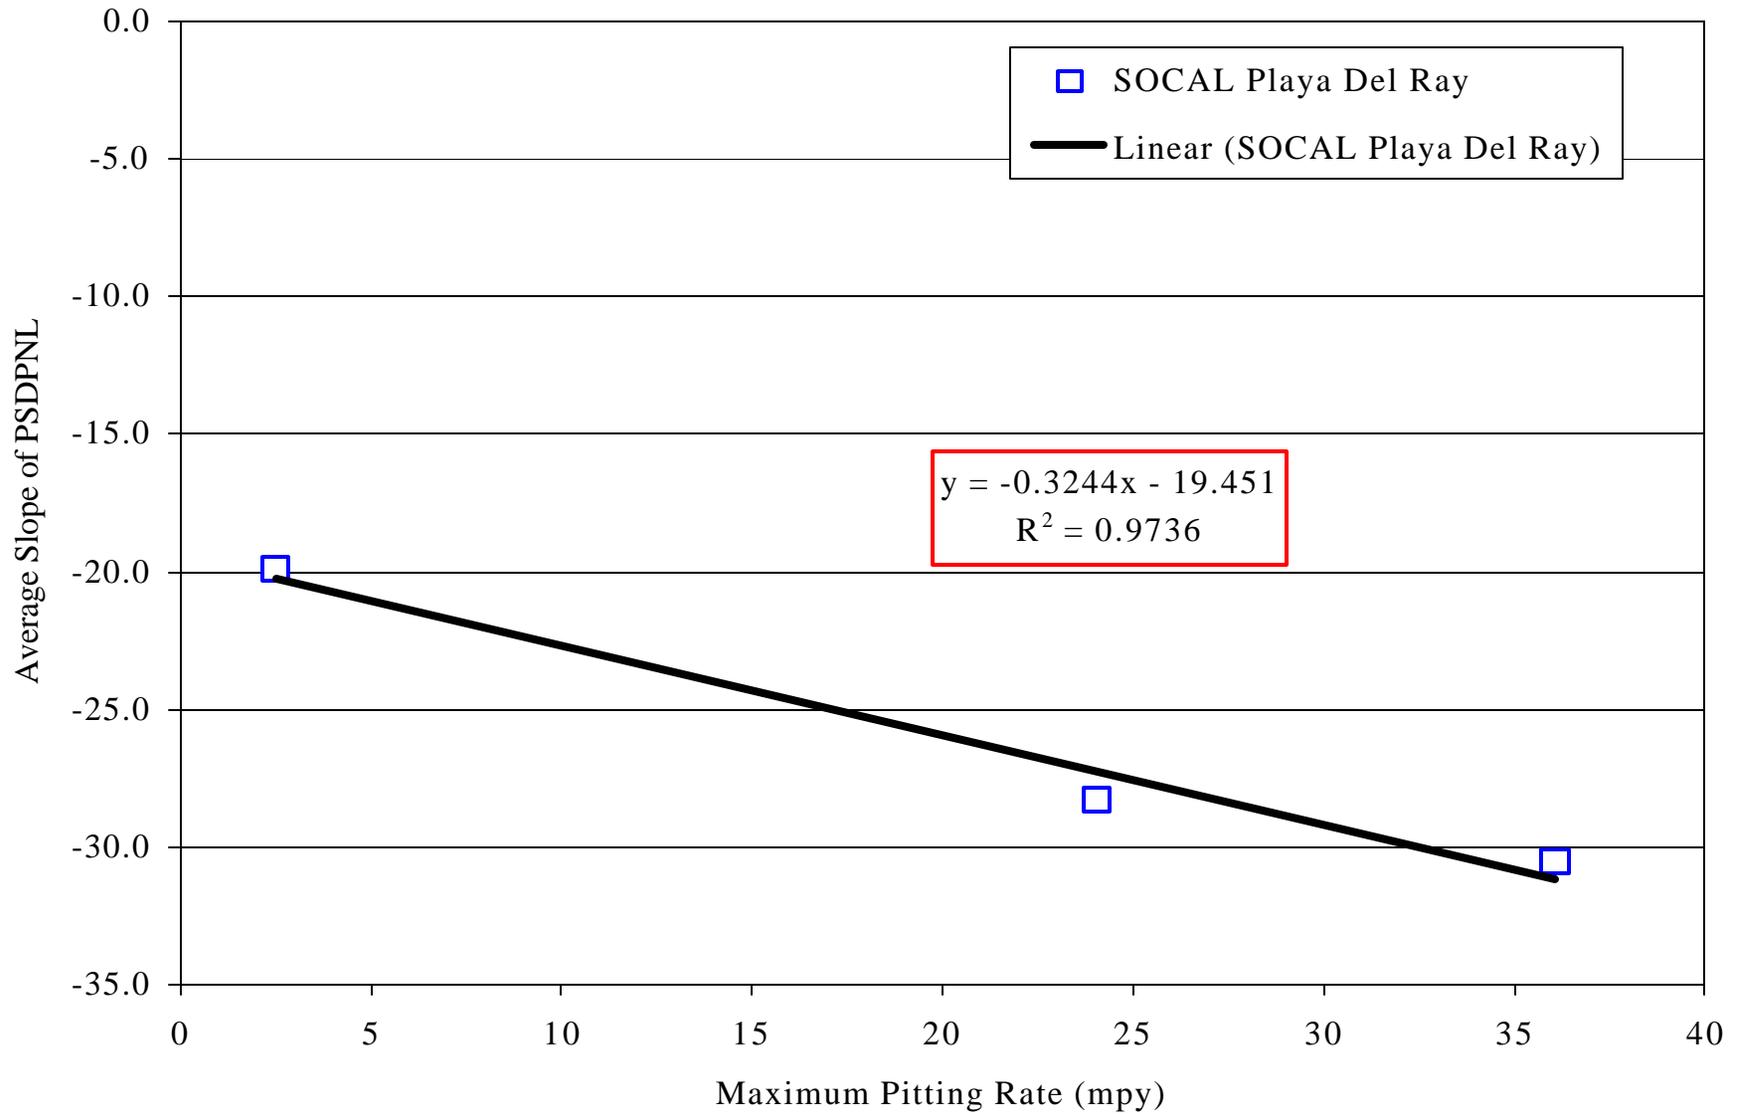
Figure 30 Correlations of the Average Slopes of PSDPNL and the Maximum Pitting Rate.

The on-line ECN analysis system was field tested in a natural gas storage facility in southern California. The ECN analysis system was demonstrated to be able to detect the SLP corrosion on the monitored facilities. The slopes of PSDPNL were correlated very well with the maximum pitting rate measured by the microscope.

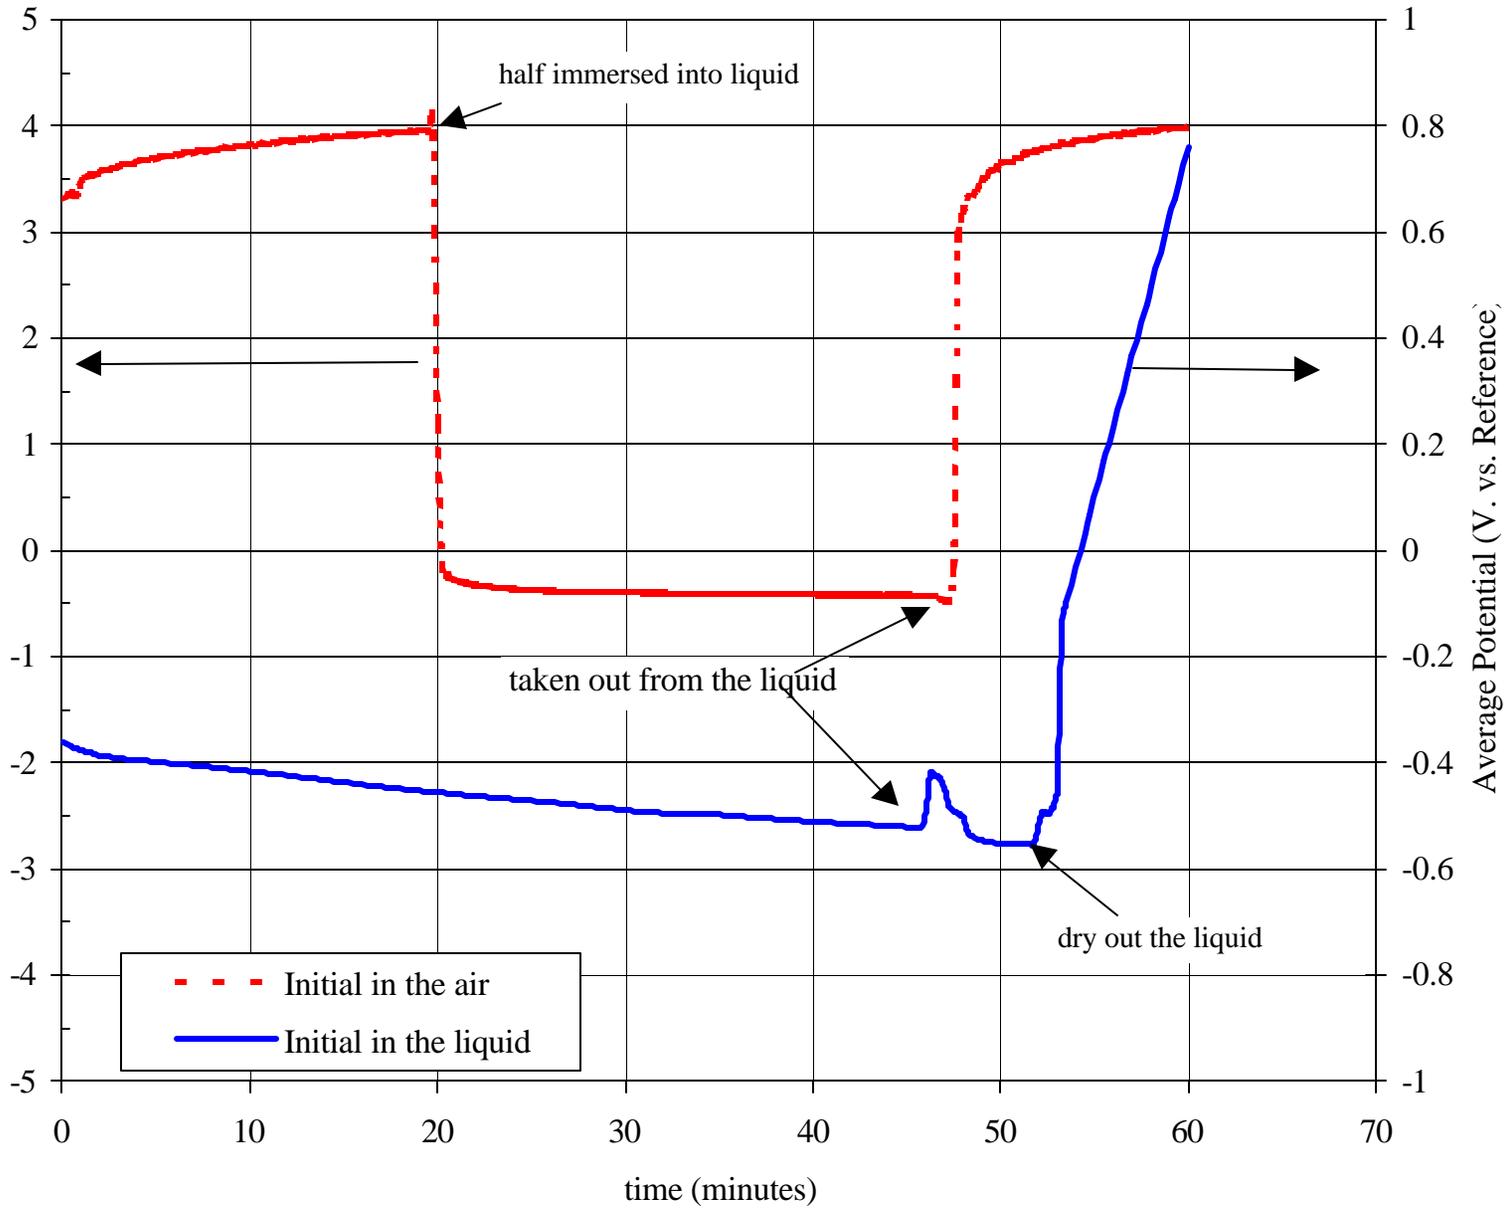
Figure 33 Effects of Liquid Levels on the Potential Readings

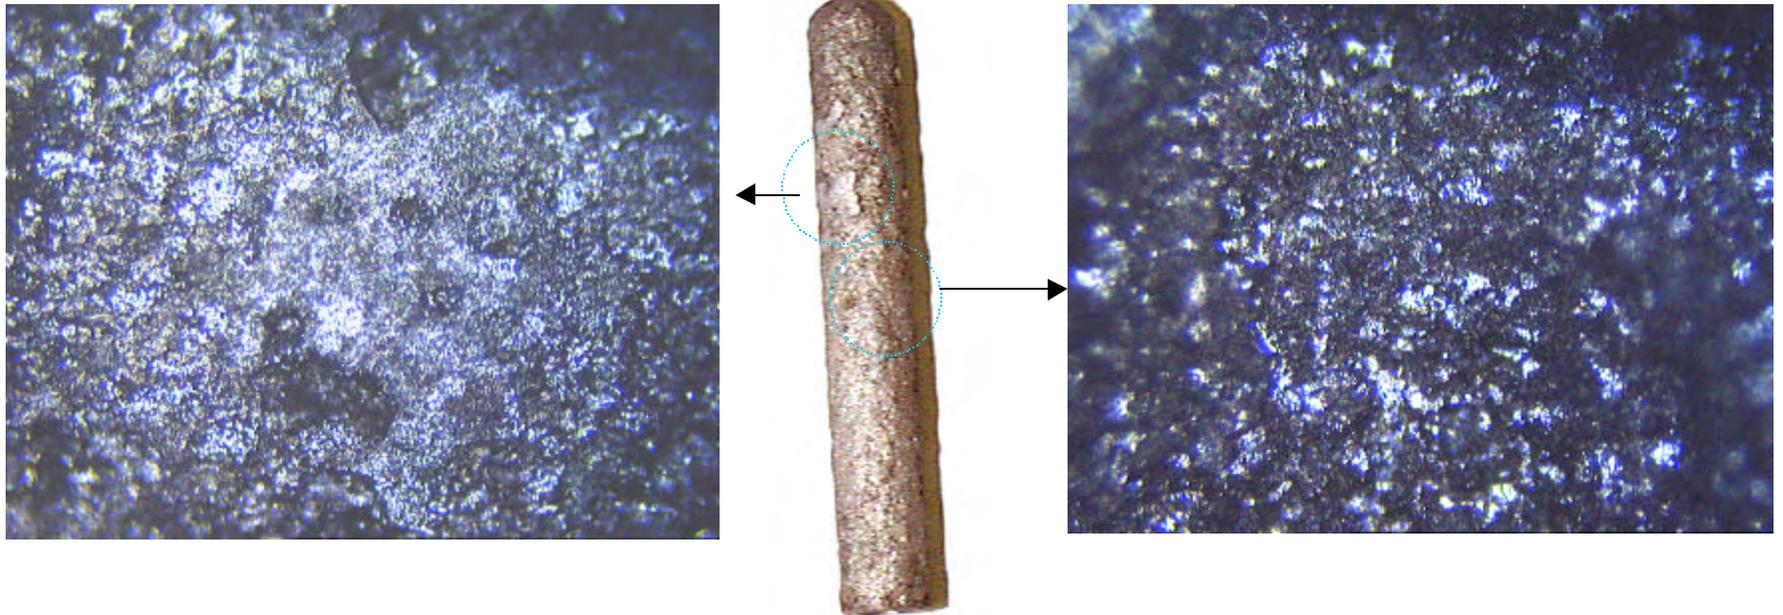
working electrode I of Probe 1 in the “udder” of V140 (SOCAL1\_W1)  
severe uniform pitting corrosion -  
Max Pitting Rate ~ 30 mpy  
Uniform Corrosion rate ~ 29 mpy

Figure D-1 (a) Morphologies of working electrode I of probe #1 in the “udder” of V140

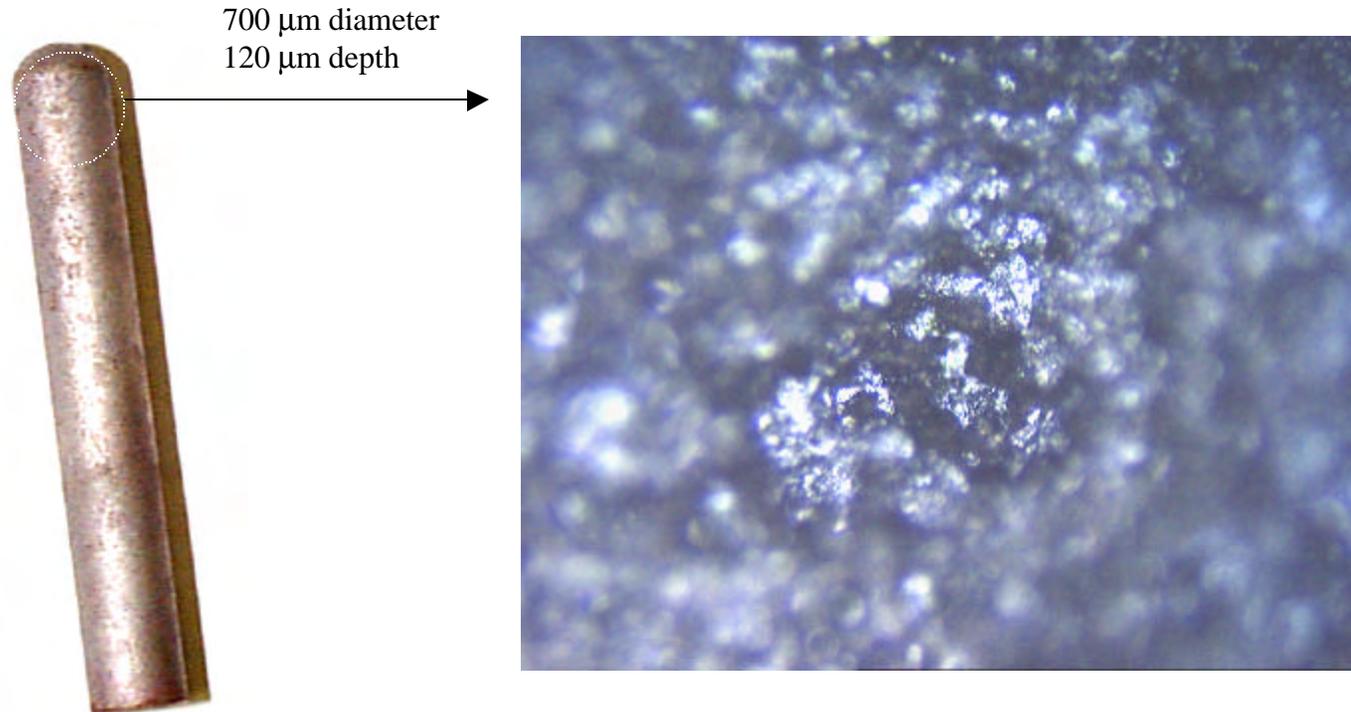
working electrode II of Probe 1 in the “udder” of V140 (SOCAL1\_C1)  
sustained localized pitting corrosion -

Max Pitting Rate  $\sim 36$  mpy

Uniform Corrosion rate  $\sim 7$  mpy

Figure D-1 (b) Morphologies of working electrode II of probe #1 in the “udder” of V140

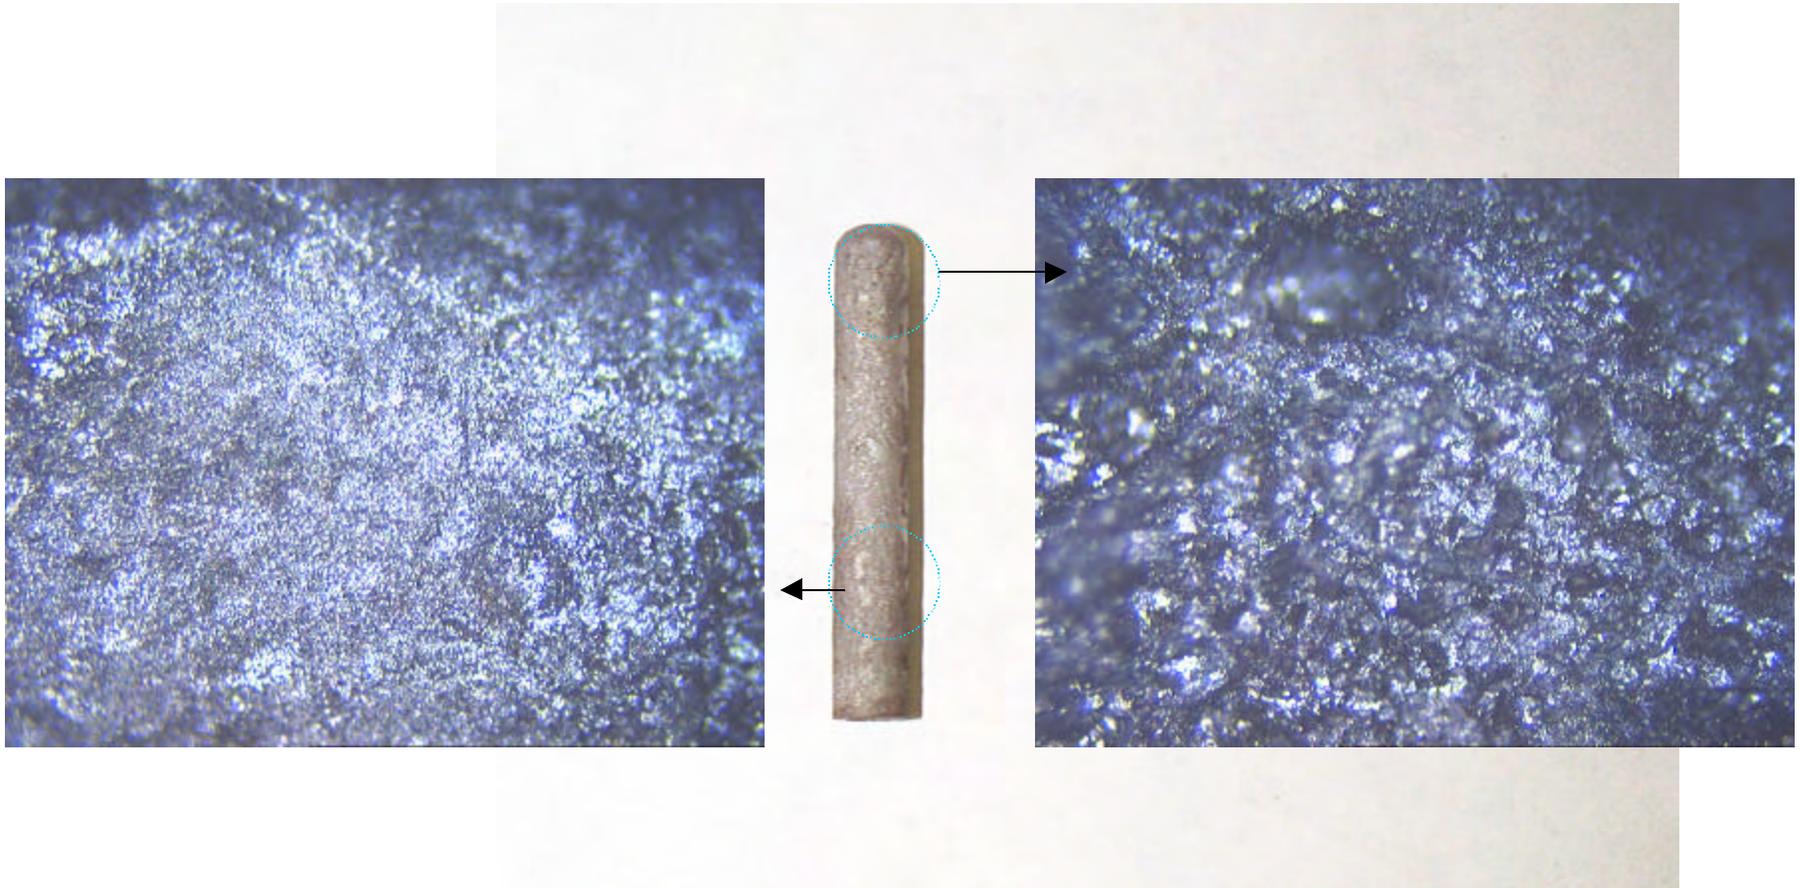
working electrode I of Probe 2 in the “udder” of V140 (SOCAL1\_W1)  
severe pitting corrosion -  
Max Pitting Rate ~ 24 mpy  
Uniform Corrosion rate ~ 14 mpy

Figure D-2 (a) Morphologies of working electrode I of probe #2 in the “udder” of V140

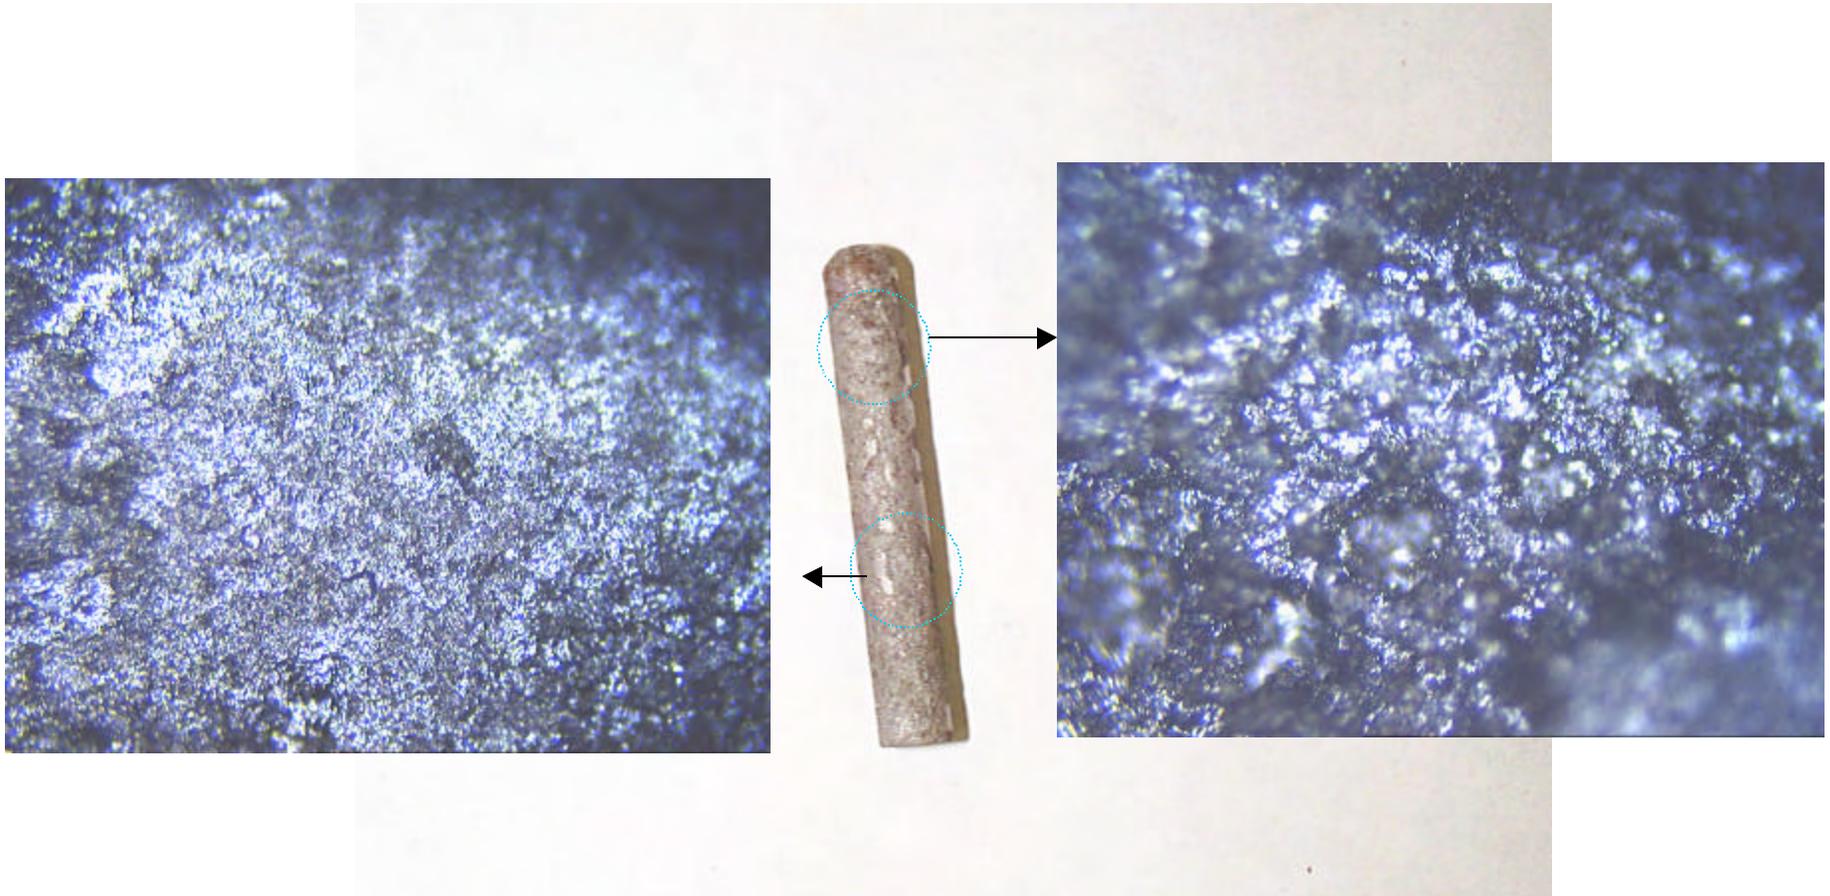
working electrode II of Probe 2 in the “udder” of V140 (SOCAL1\_C2)  
severe pitting corrosion -

Max Pitting Rate ~ 14 mpy

Uniform Corrosion rate ~ 16 mpy

Figure D-2 (b) Morphologies of working electrode II of probe #2 in the “udder” of V140

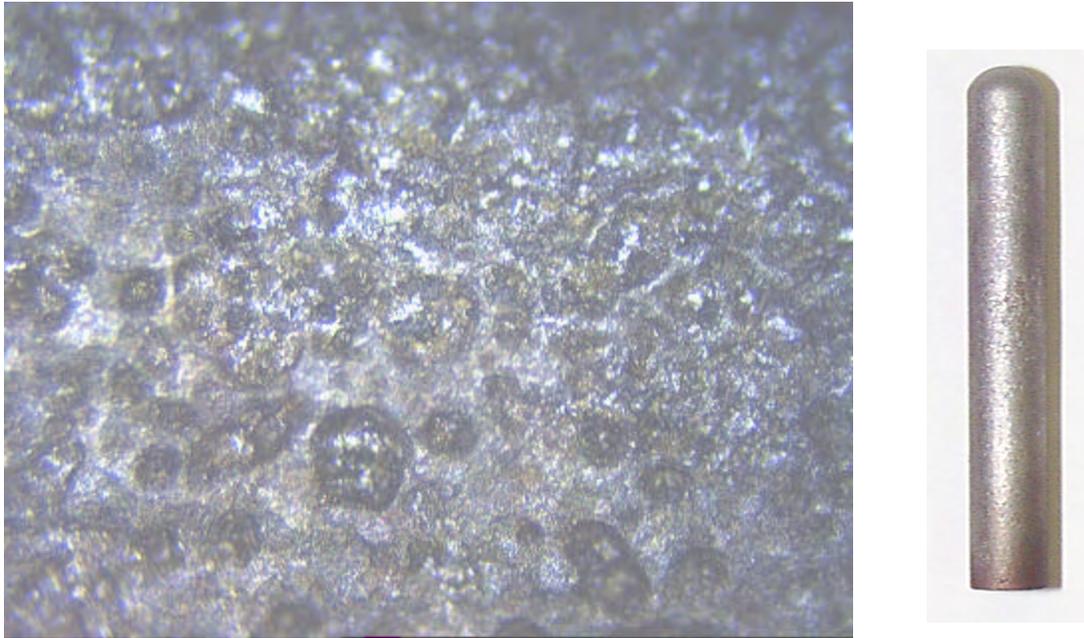
working electrode I of Probe 1 in the “bottom” of V140 (SOCAL2\_W1)  
localized pitting corrosion -

Max Pitting Rate ~ 3.7 mpy

Uniform Corrosion rate ~ 2.48 mpy

Figure D-3 (a) Morphologies of working electrode I of probe #1 in the “bottom” of V140

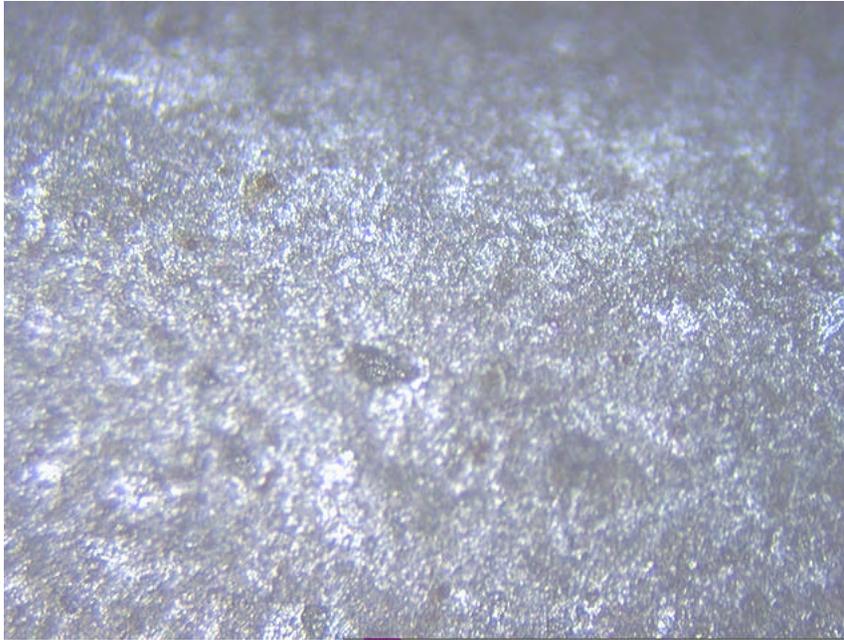
working electrode II of Probe 1 in the “bottom” of V140 (SOCAL2\_C1)  
uniform corrosion –

Uniform Corrosion rate ~ 0.46 mpy

Figure D-3 (b) Morphologies of working electrode II of probe #1 in the “bottom” of V140

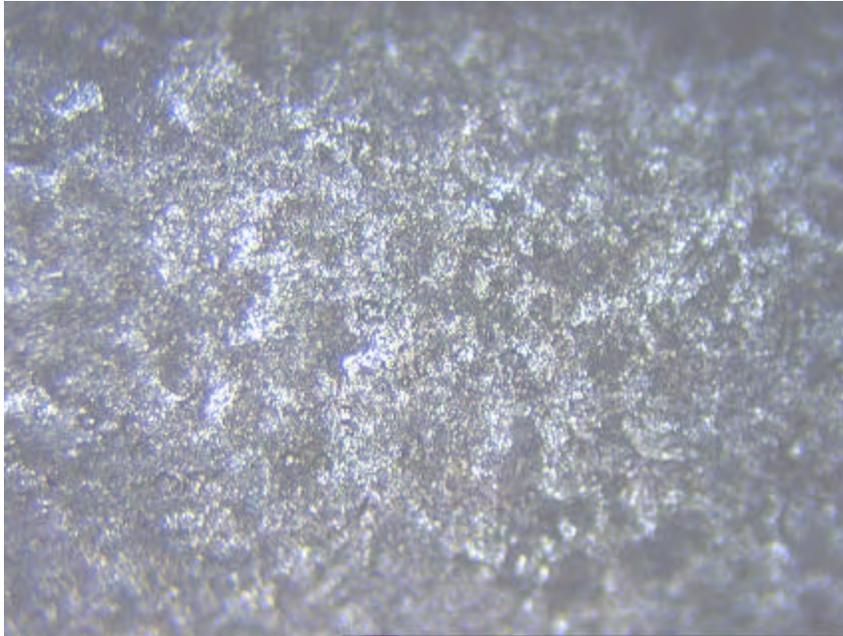
working electrode I of Probe 2 in the “bottom” of V140 (SOCAL2\_W2)  
uniform corrosion –

Uniform Corrosion rate ~ 0.43 mpy

Figure D-4 (a) Morphologies of working electrode I of probe #2 in the “bottom” of V140

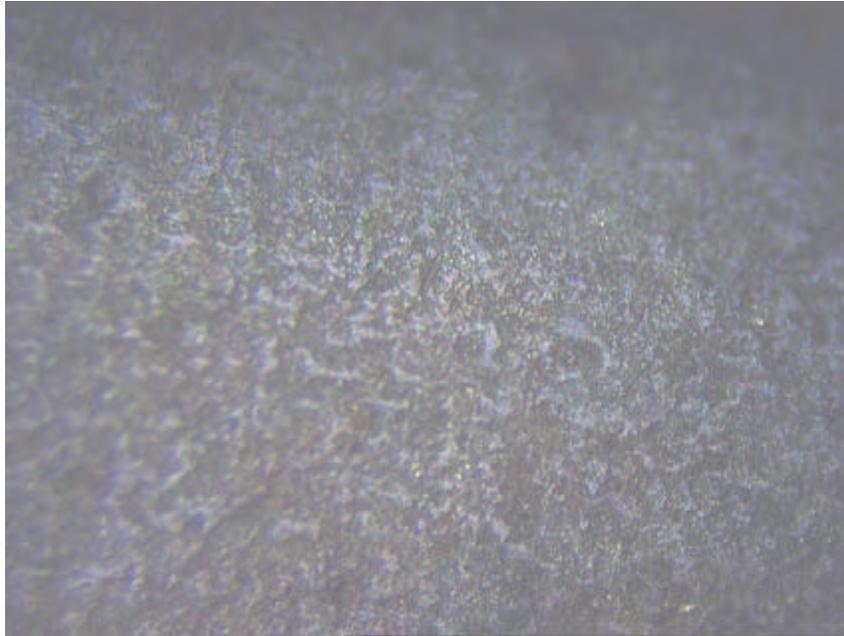
working electrode II of Probe 2 in the “bottom” of V140 (SOCAL2\_C2)  
uniform corrosion –

Uniform Corrosion rate ~ 0.39 mpy

Figure D-4 (b) Morphologies of working electrode II of probe #2 in the “bottom” of V140

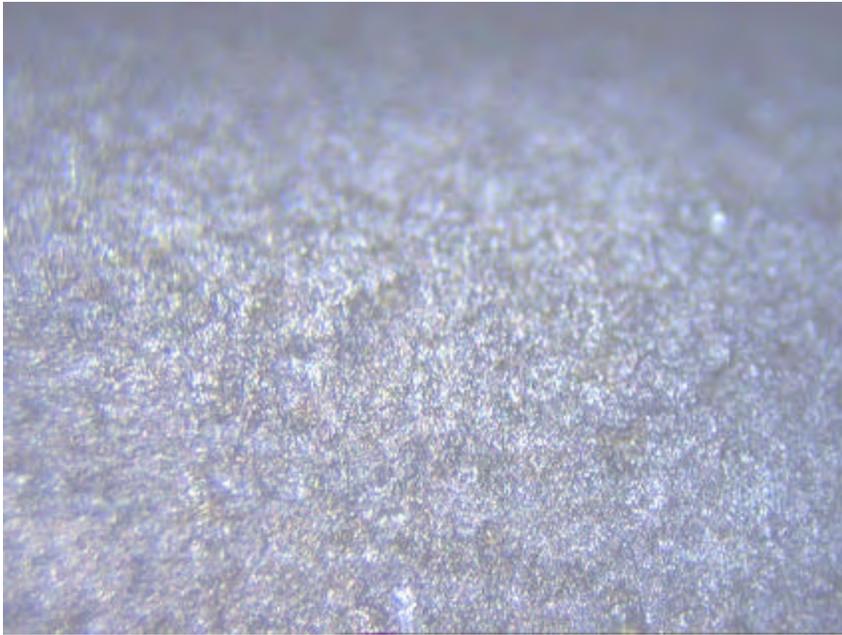
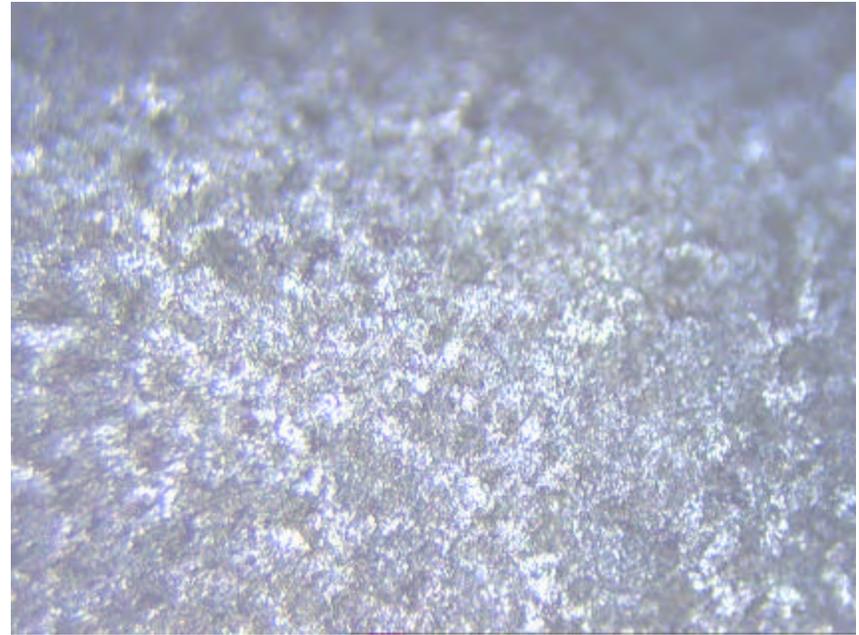
working electrode I of Probe 1 in the third location  
of SOCAL (SOCAL3\_W1)  
uniform corrosion –  
Uniform Corrosion rate ~ 0.77 mpy

working electrode II of Probe 1 in the third location  
of SOCAL (SOCAL3\_C1)  
uniform corrosion –  
Uniform Corrosion rate ~ 0.15 mpy

Figure D-5 Morphologies of the working electrodes of probe #1 in the third location of SOCAL

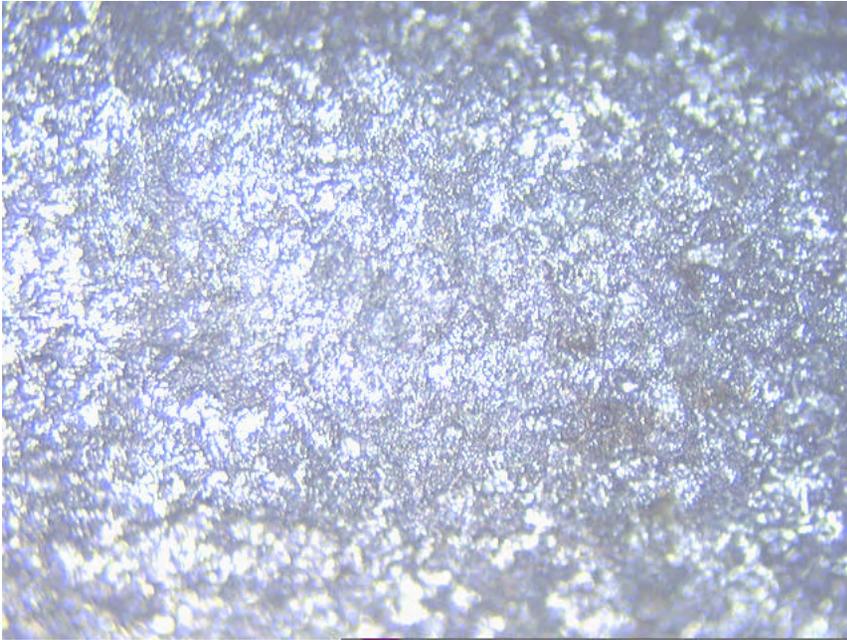
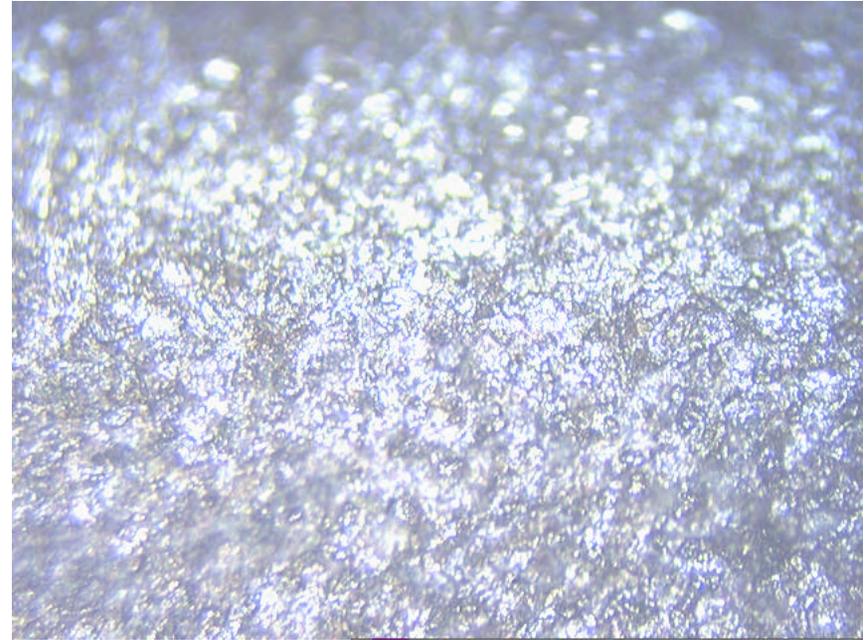
working electrode I of Probe 1 in the third location  
of SOCAL (SOCAL3\_W2)  
uniform corrosion –  
Uniform Corrosion rate ~ 0.27 mpy

working electrode II of Probe 1 in the third location  
of SOCAL (SOCAL3\_C2)  
uniform corrosion –  
Uniform Corrosion rate ~ 0.91 mpy

Figure D-6 Morphologies of the working electrodes of probe #2 in the third location of SOCAL
